Deepwater Program: Exploration and Research of Northern Gulf of Mexico Deepwater Natural and Artificial Hard Bottom Habitats with Emphasis on Coral Communities: Reef, Rigs and Wrecks "Lophelia II"

**Cruise 2 Report - Sentry AUV
17 June – 1 July 2009**

TDI-BROOKS INTERNATIONAL, INC.
Technical Report No. – 09-2284

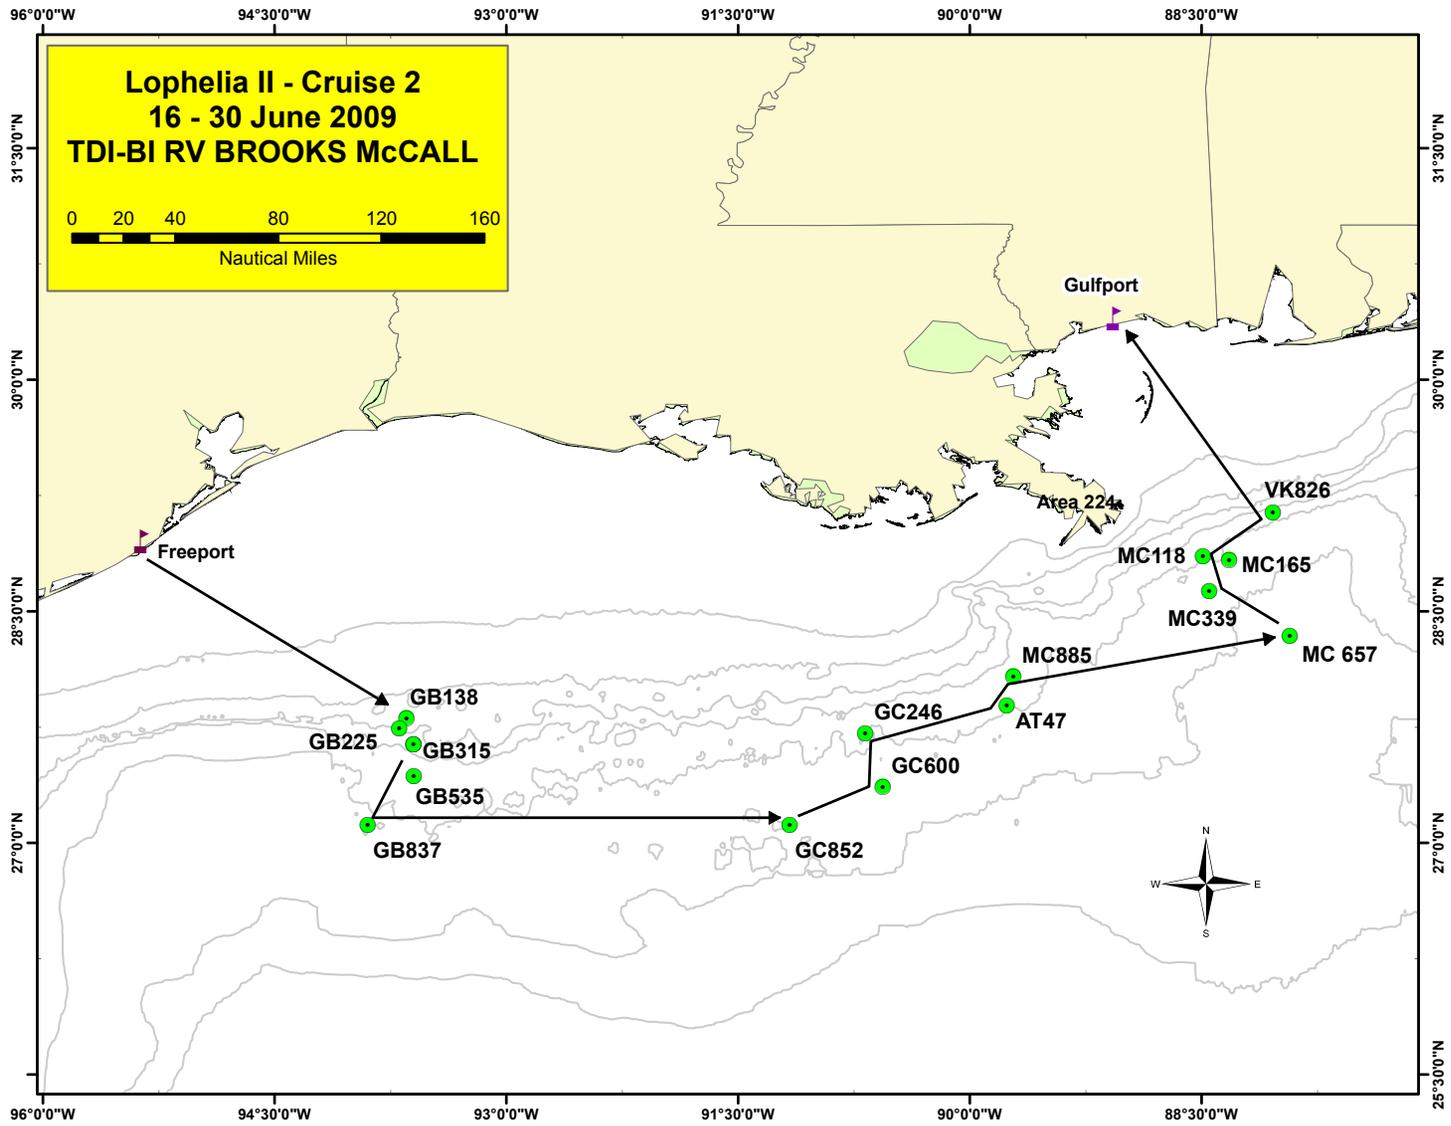
Figure 1. Sites visited – Cruise 2.

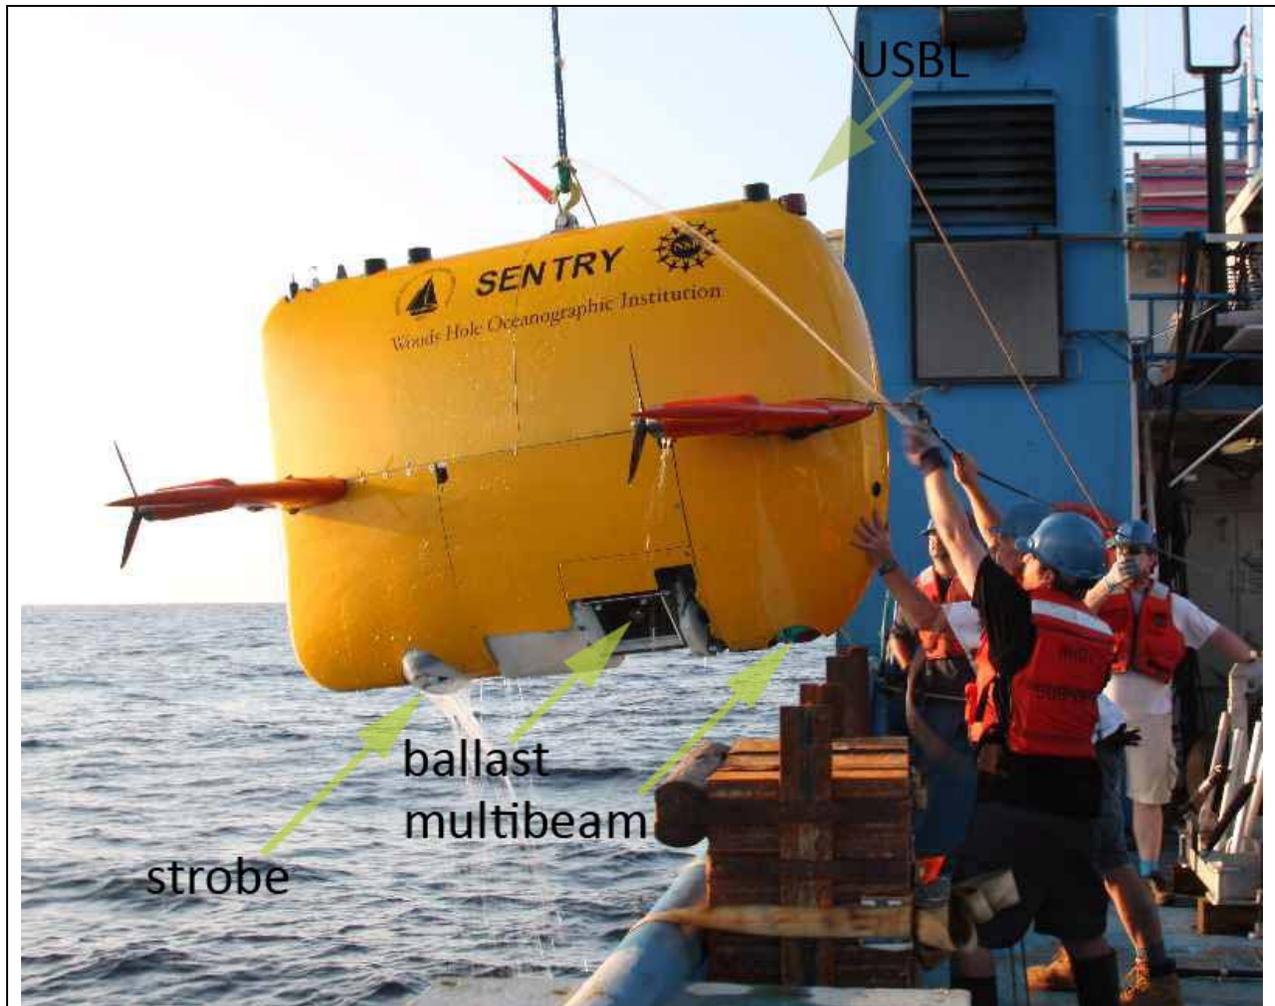
Figure 2. AUV Sentry being recovered onto the RV Brooks McCall following a successful dive. Arrows and labels indicate locations of system components described in the text.

Sentry has been deployed from the port side of the ship, using the crane to deploy and recover the vehicle. **Figure 2** shows the recovery of Sentry following a completed dive. Prior to each dive, the chief scientist (MacDonald) and the AUV mission programmer (Yoerger) develop a survey plan for the upcoming dive. The surveys include transect lines for multibeam at altitudes of about 50 m and transit lines for photographic survey at altitudes of about 5 m. MMS contract officer (Shedd) is consulted on survey design. Survey targeting has generally selected steep escarpments and hard bottom areas.

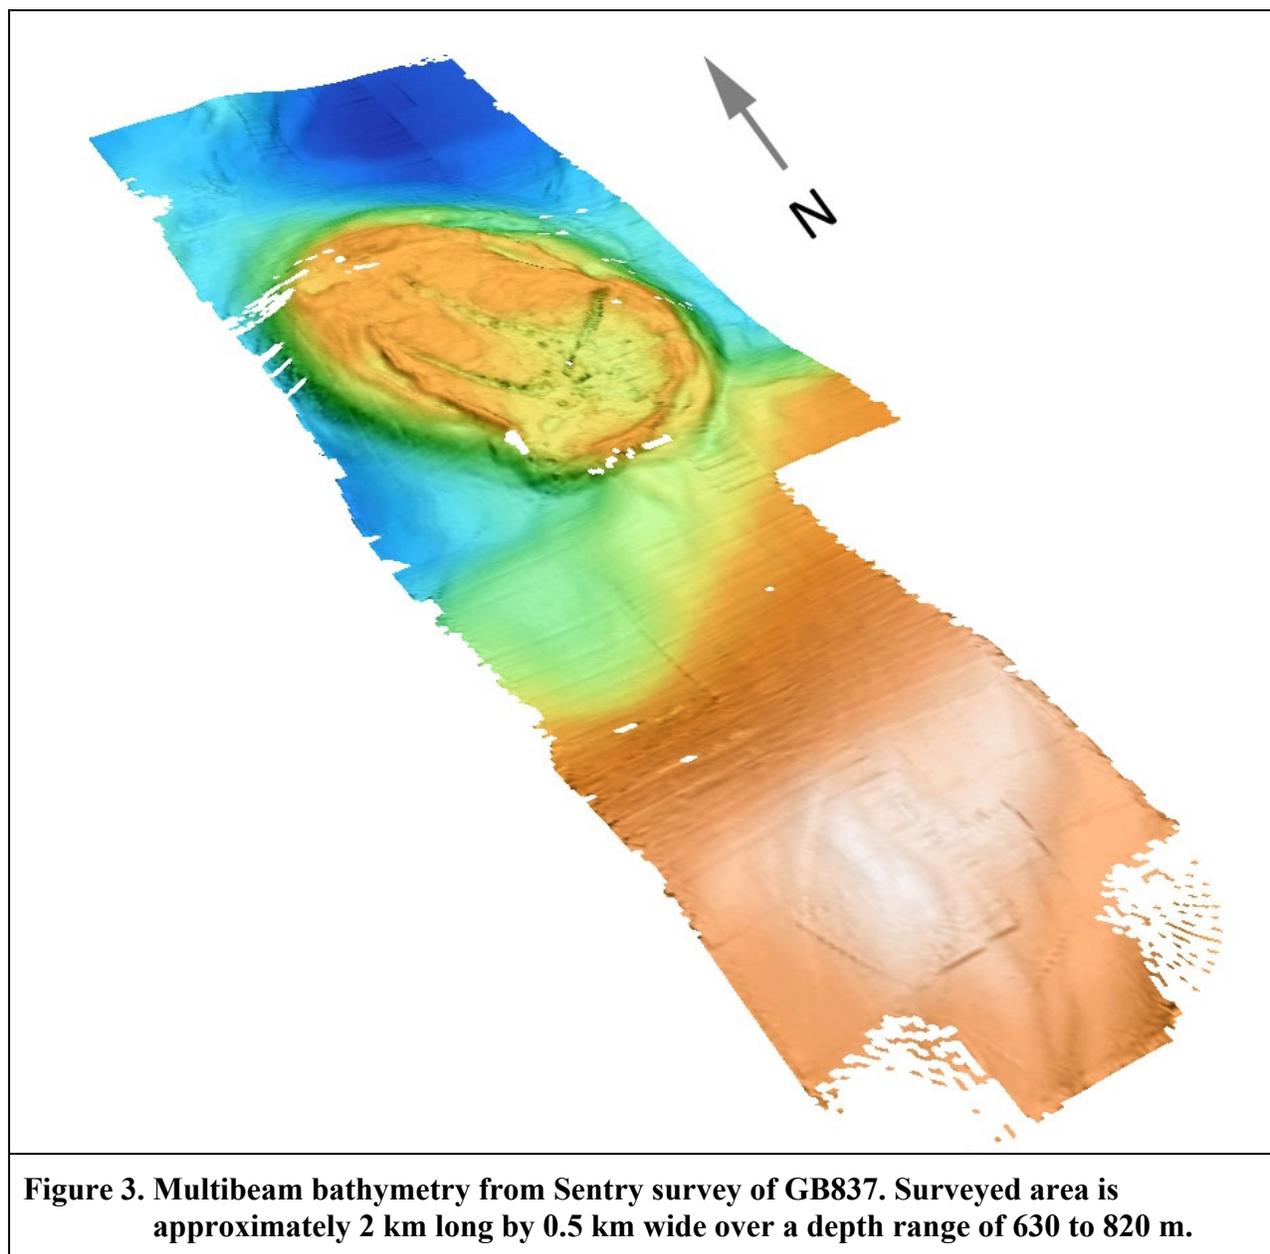
The surveyed area of GB837 consisted of two circular mounds and hard ground (**Figure 3**). Sentry completed a 13.6 hour survey covering 33.5 km of trackline at an average altitude of 58 m. **Figure 3** shows a partially filtered display of the bathymetry from this site. The camera system was not functional during this dive due to problems with the strobe, but a preliminary interpretation of the backscatter suggests that there were active mud flows and possibly mud volcanism at the site.

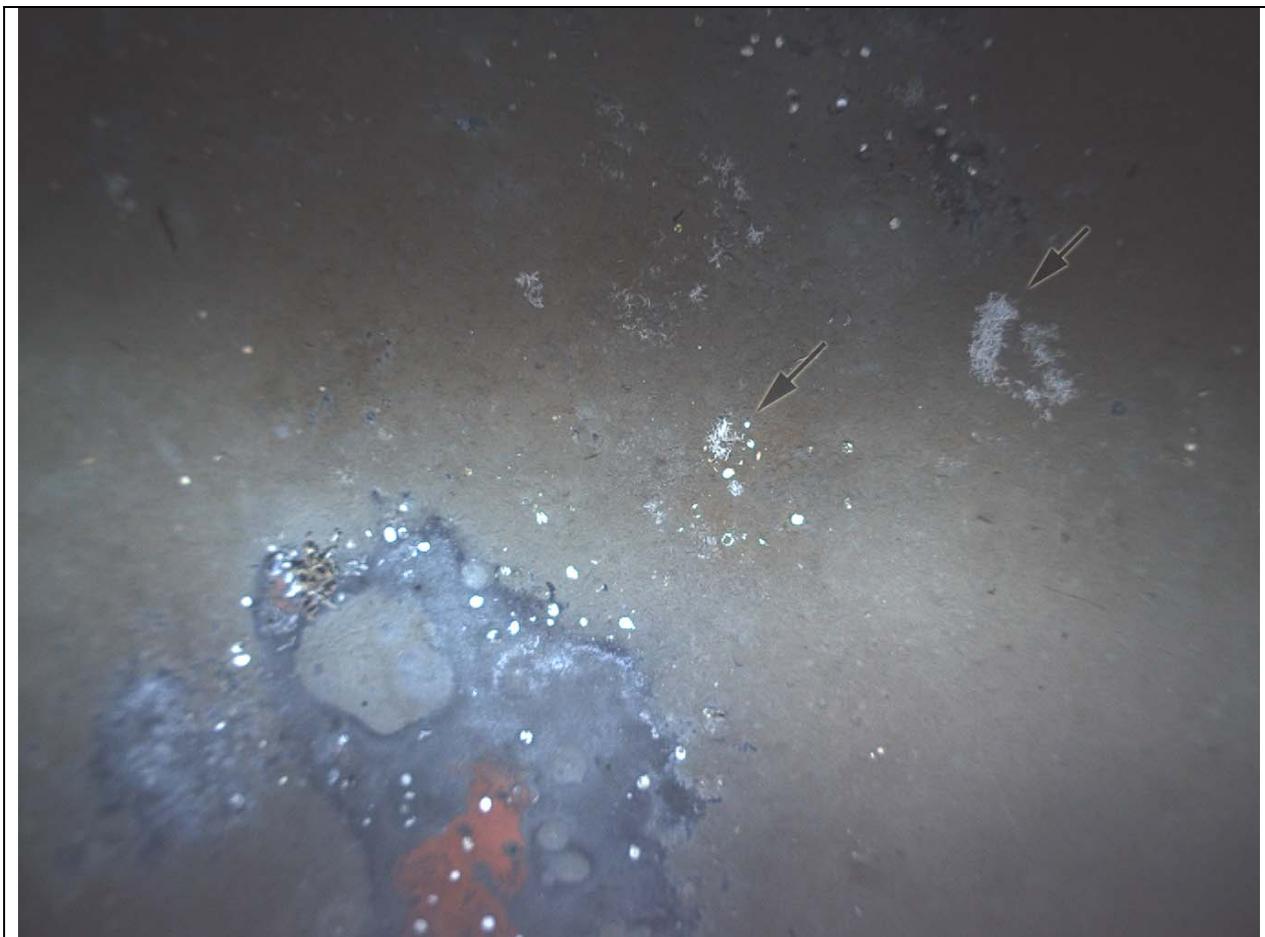
Figure 4. Seep fauna and possible *Lophelia* colony photographed during survey of GB535. Mussels and bacterial mats are evident in the foreground to left.

The survey at GB535 was abbreviated due to concerns about the inertial navigation system described below. Consequently, it focused on a central high ground, but avoided steep, hard-ground slopes to the south that had originally been targeted. The survey was completed in 10.0 hours and covered 28.9 km. Photographs were taken along a ~1km track along the edge and top of the mound; the photo track targeted the seismic high-amplitude areas. This feature contained numerous seep features, including bacterial mats, brine flows, and seep mussels. One image (**Figure 4**) showed possible colonies of *Lophelia*. This identification is not definitive and it is possible that the white objects were particularly dense examples of *Beggiatoa*.

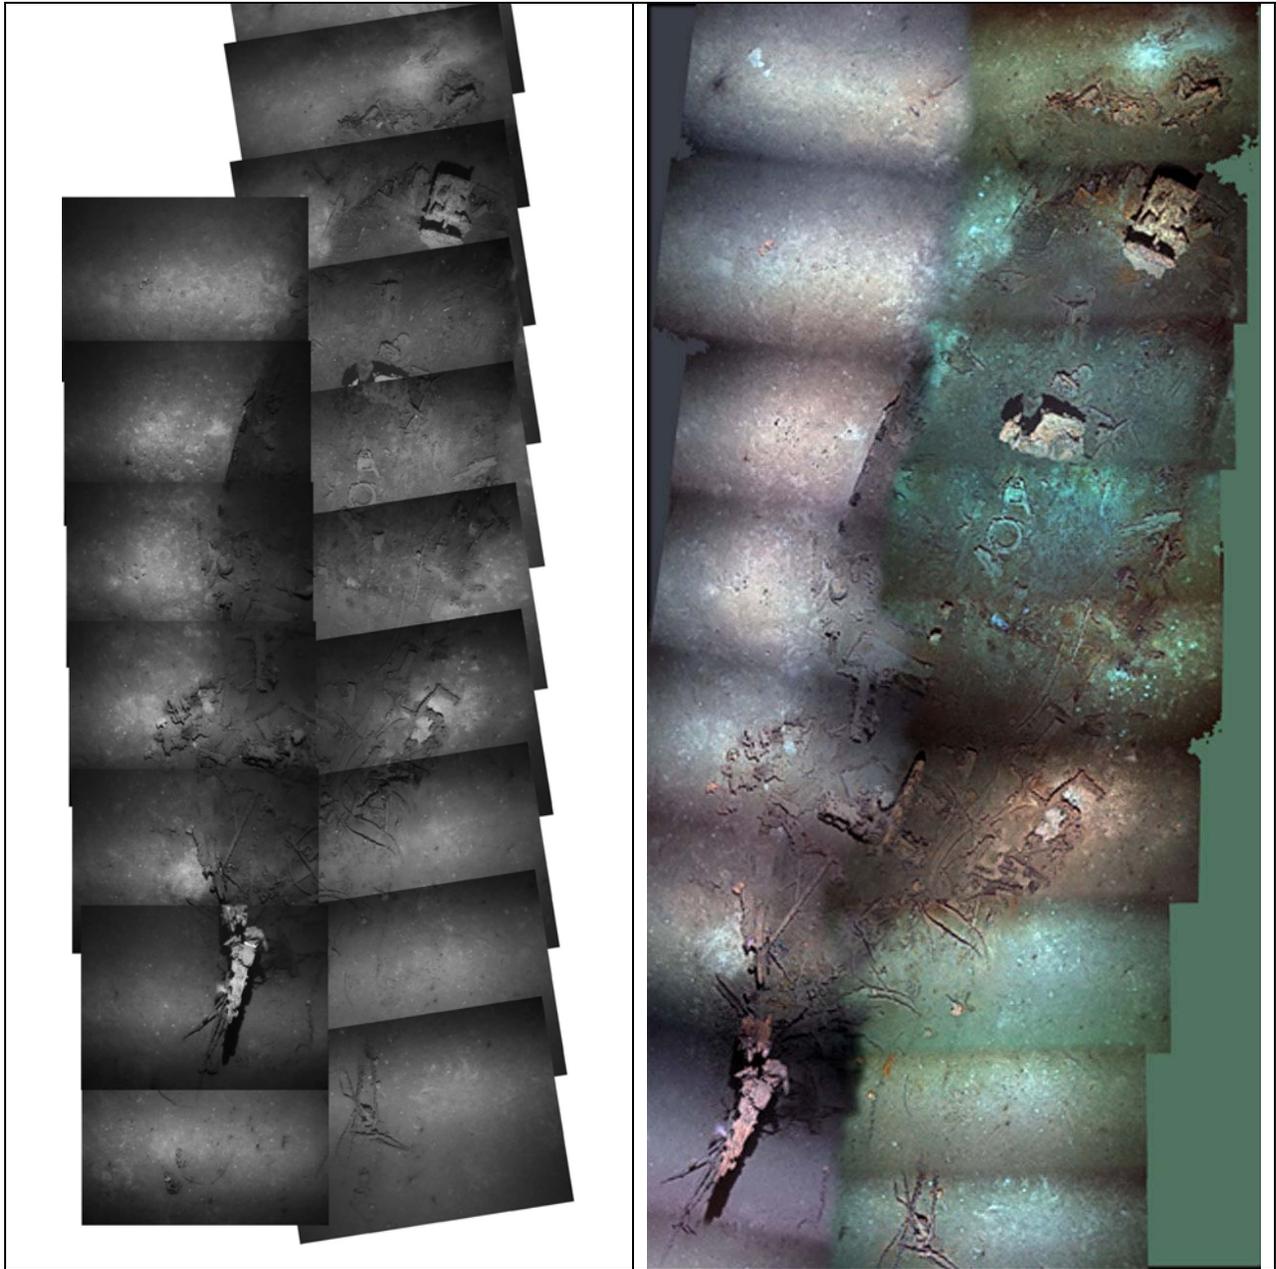
Figure 5. Stages of rendering shipwreck mosaic from MC 657

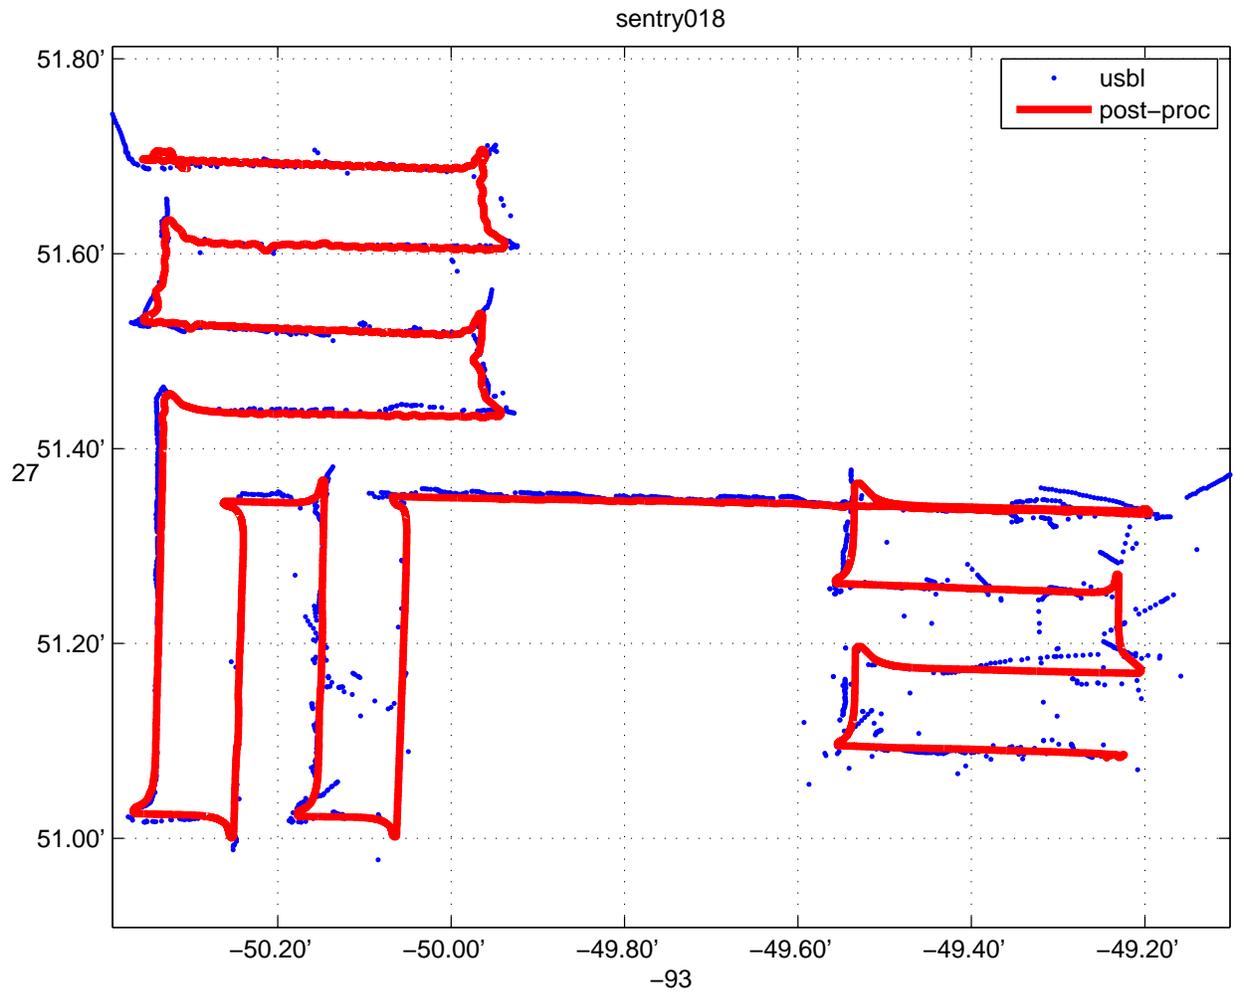
Figure 1: This plot shows the real-time USBL fixes and the post-processed dive track for Sentry018

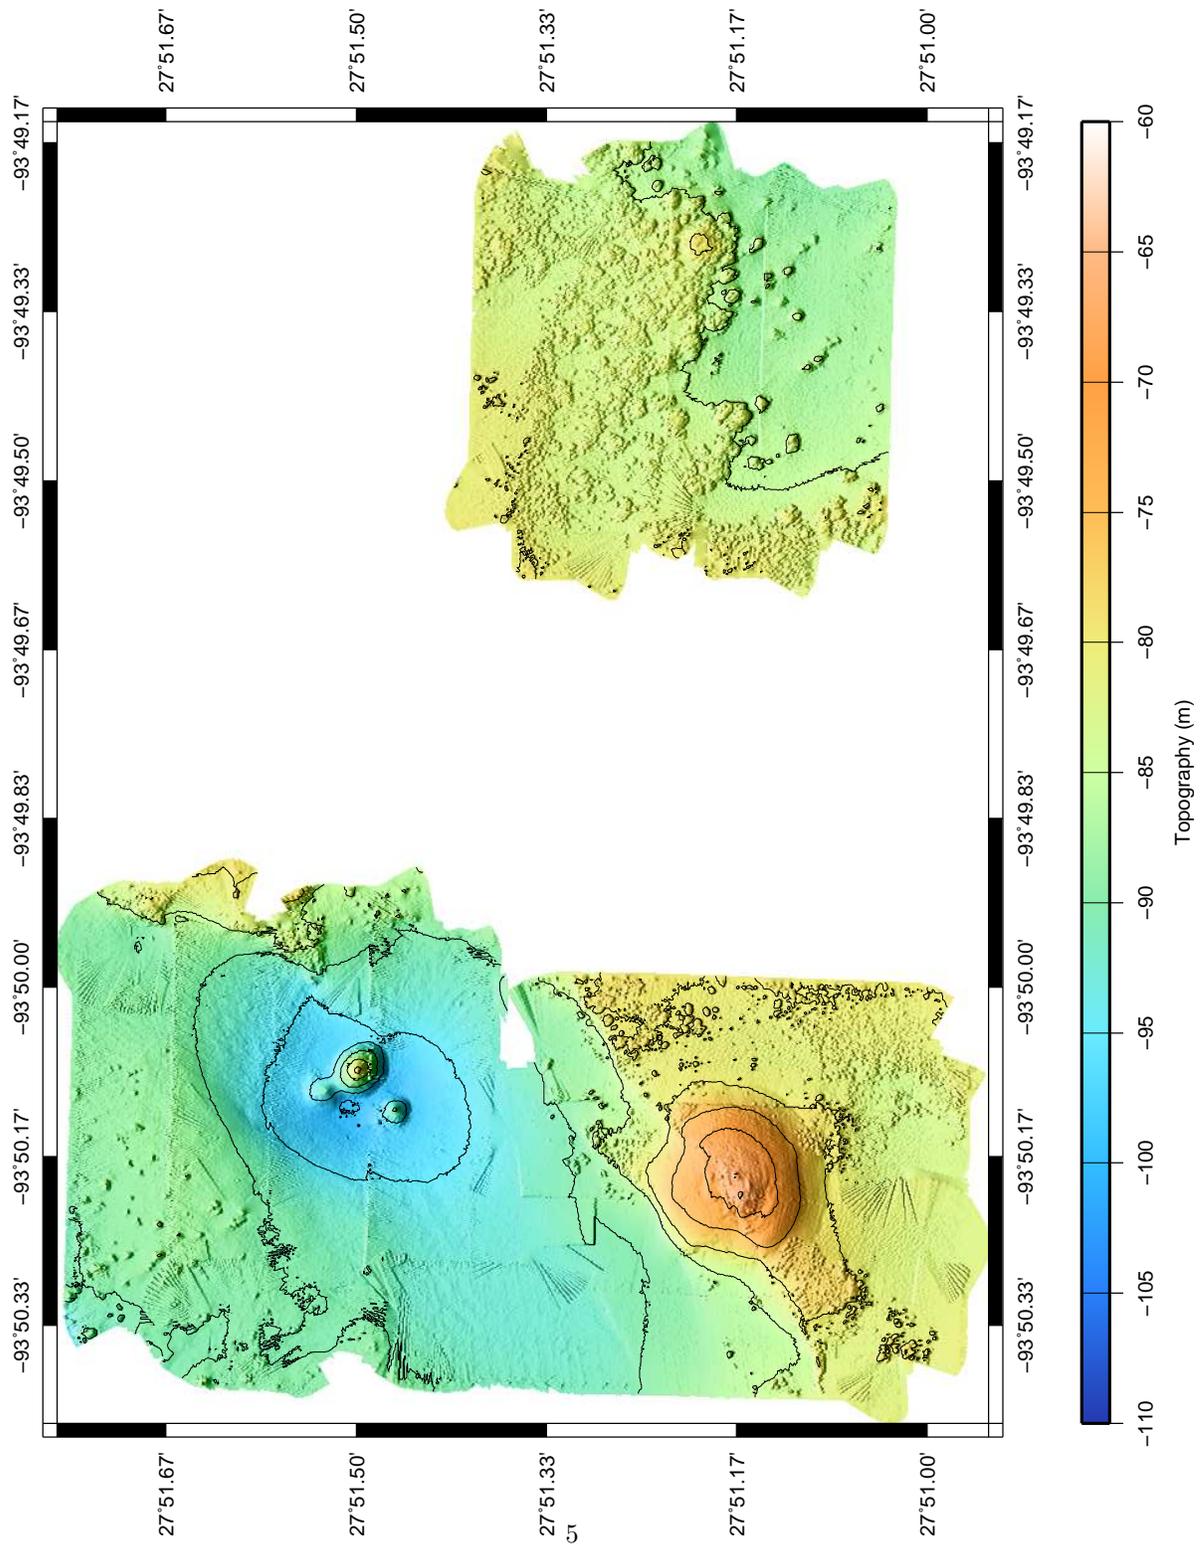
Figure 2: Processed multibeam bathymetry for Sentry018.

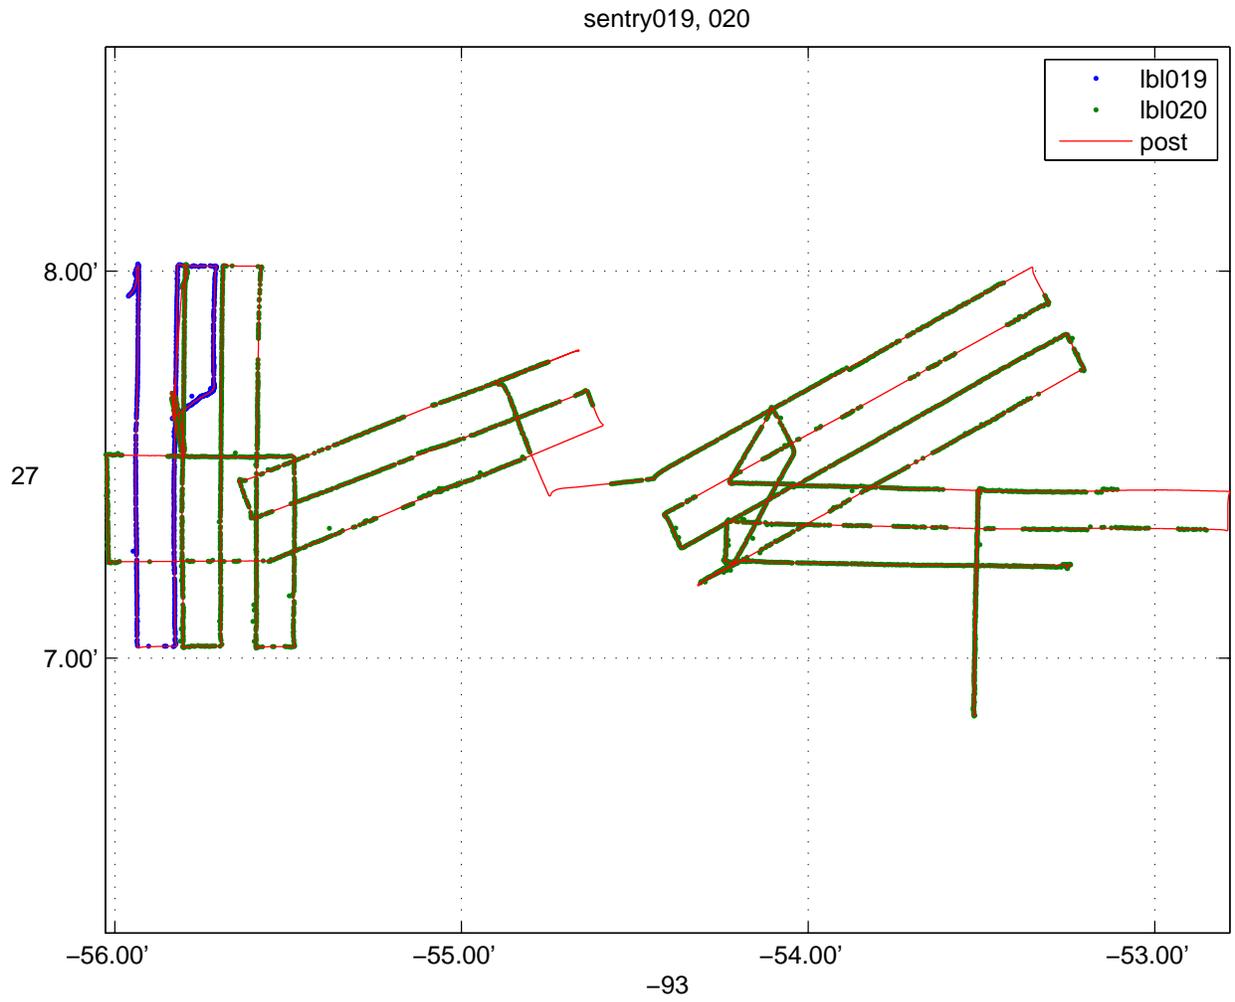
Figure 3: This plot shows the post-processed fixes and the post-processed dive track for Sentry019 and Sentry020.

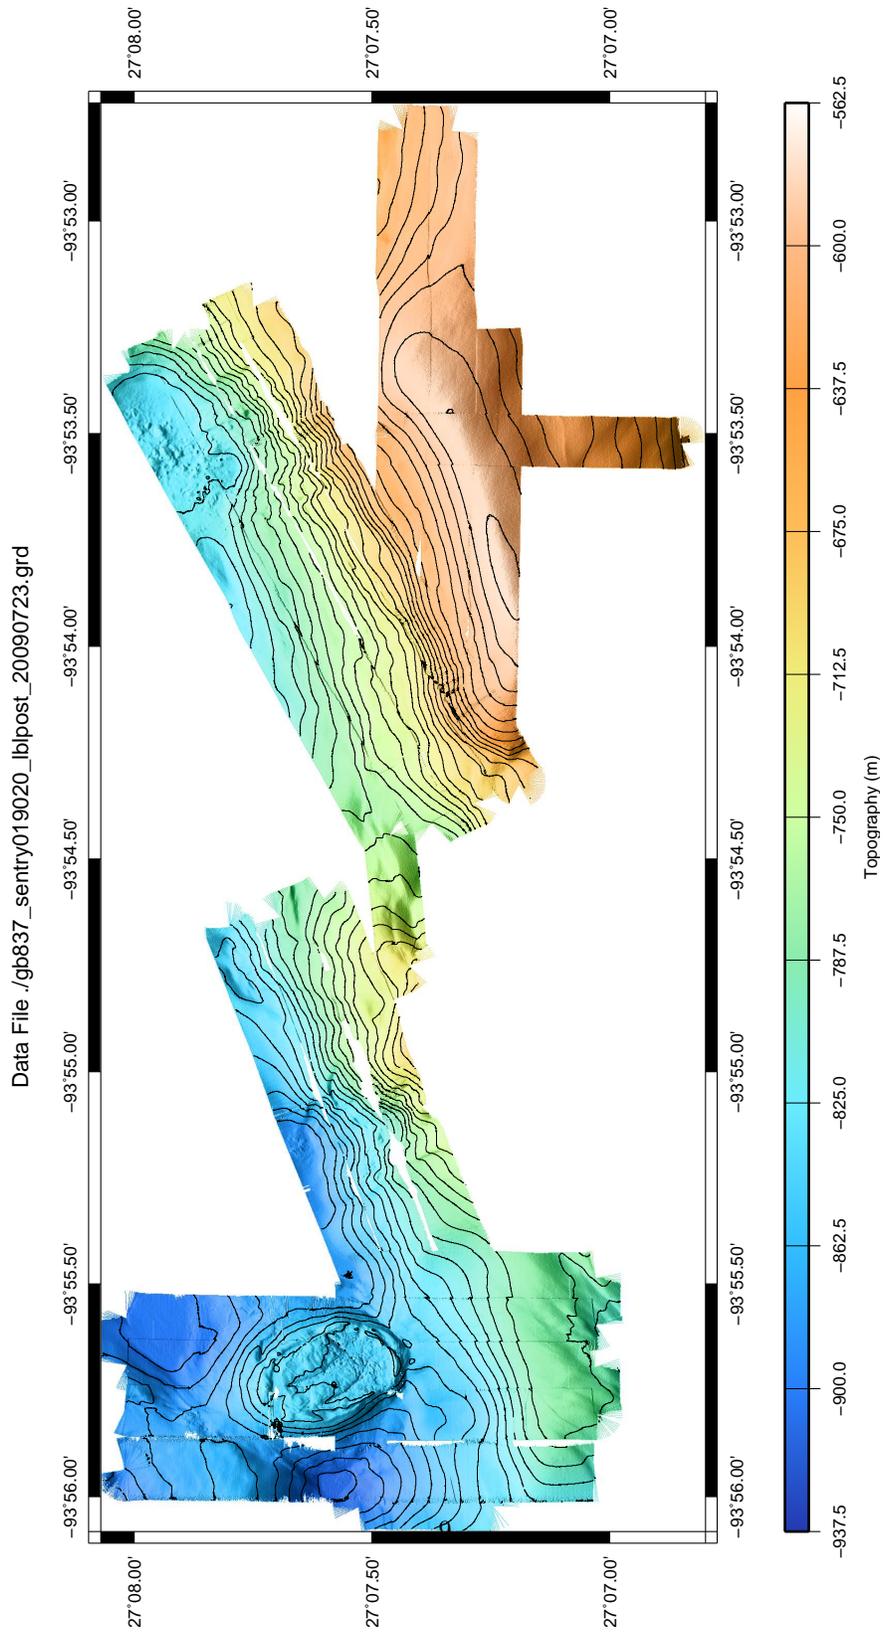
Figure 4: Processed multibeam bathymetry for Sentry019 and Sentry020, the data is gridded at 2 meters

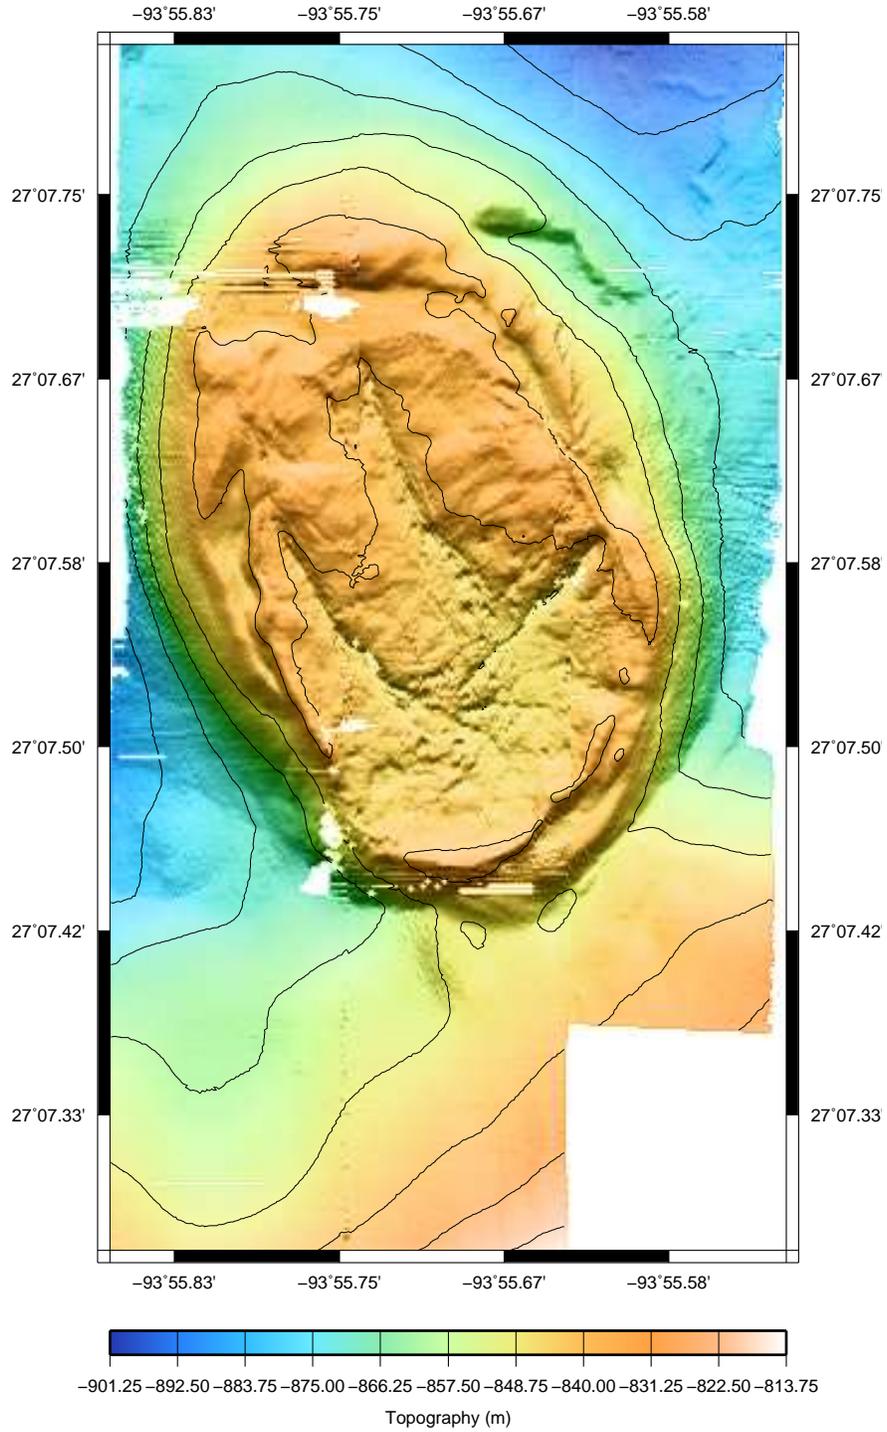
Figure 5: Processed multibeam bathymetry for the pass over the “knob” located on the west side of figure 4, gridded at 1.0 meters

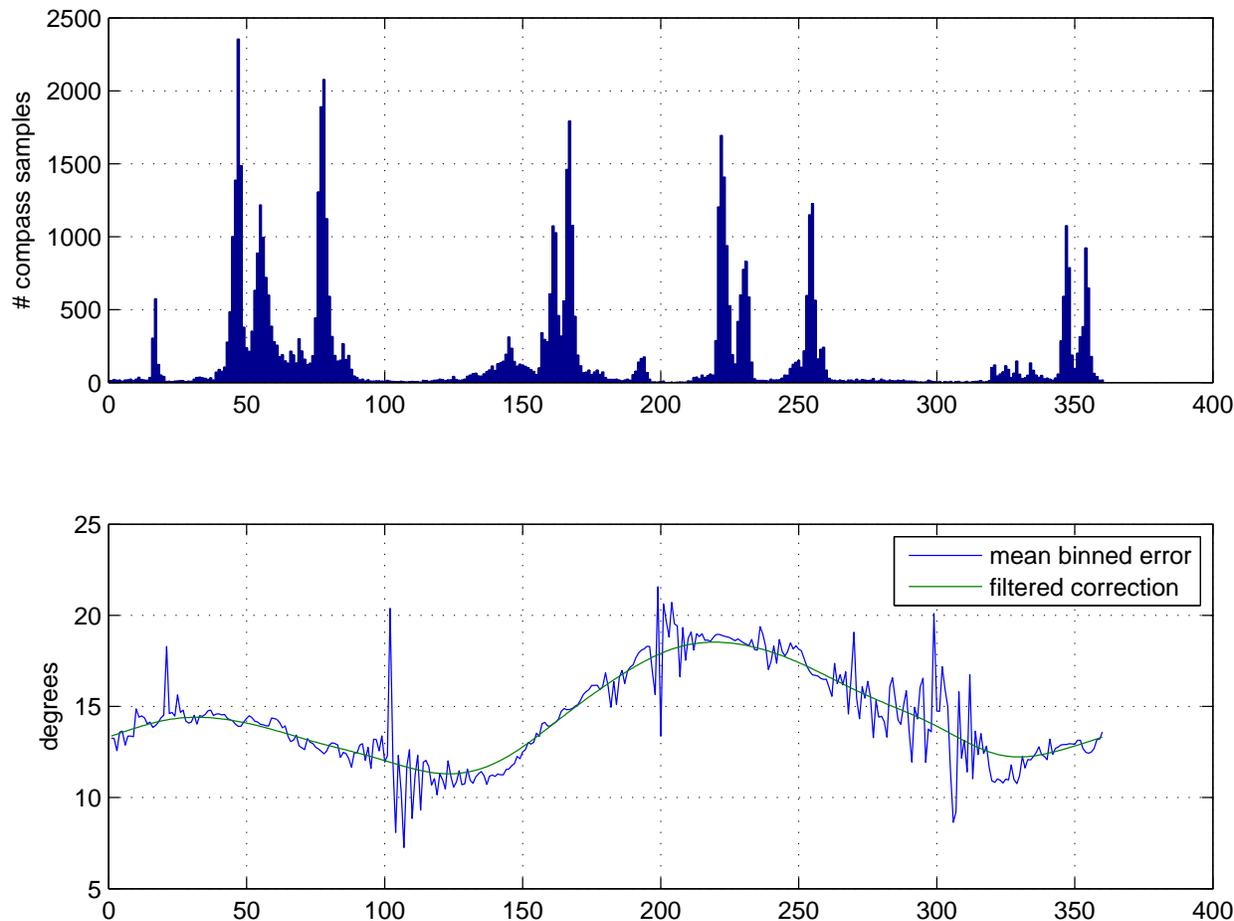
Figure 6: These plots illustrate the heading correction based on simultaneously logged data from the INS and magnetic compass from Sentry020. The upper panel shows the number of samples for 1 degree bins. The lower panel shows the correction for each 1-degree heading bin. The uneven sampling reduced the effectiveness of this approach. Our correction proved accurate for the headings with many samples (corresponding to the trackline directions from the previous dive), less accurate for the other headings where we had fewer samples and for which the vehicle was usually turning.

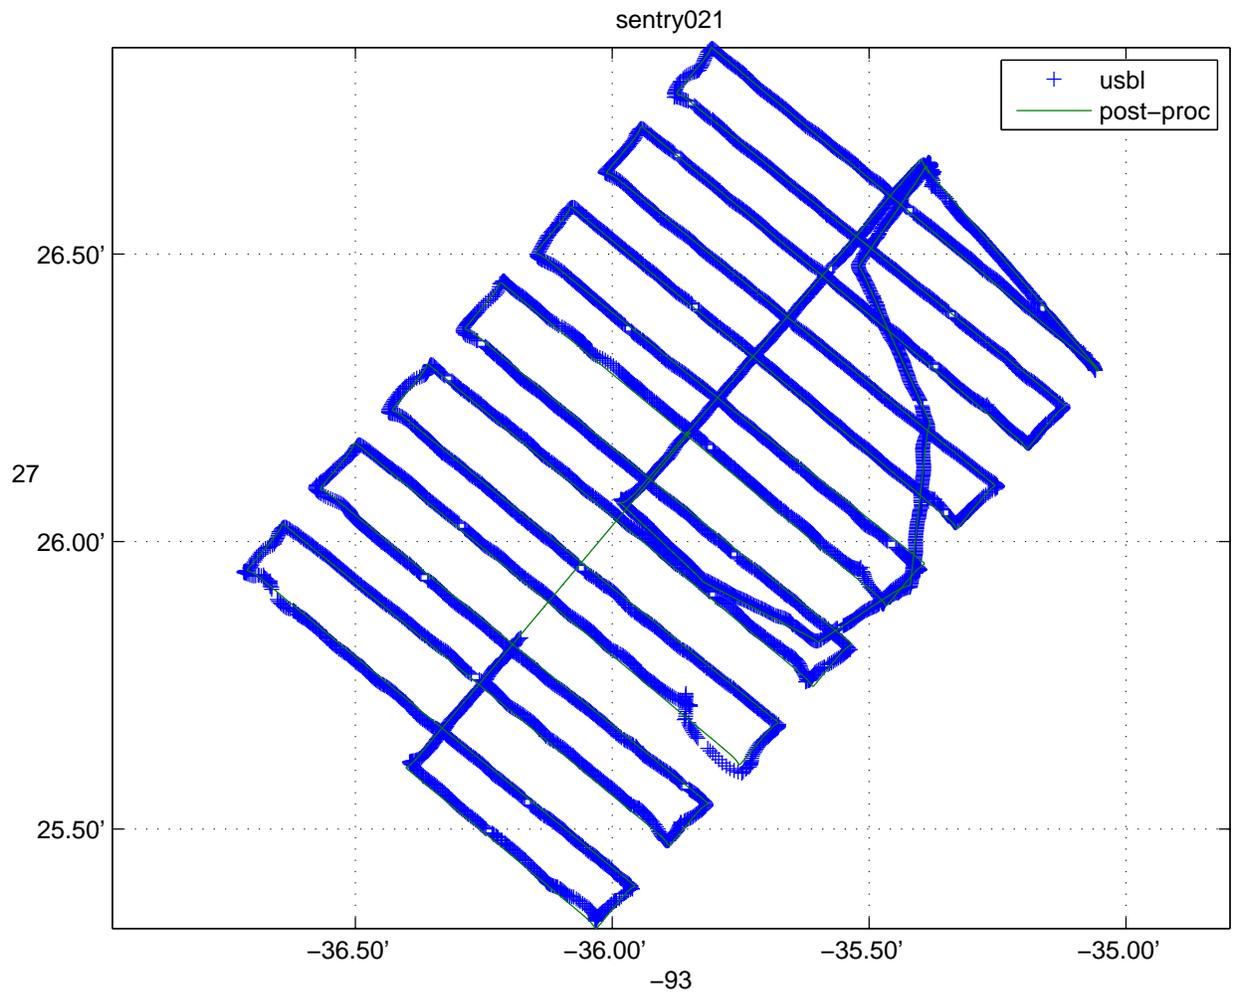
Figure 7: This plot shows the real-time USBL fixes and the post-processed dive track for Sentry021. The USBL performance at this operating depth (500m) was excellent

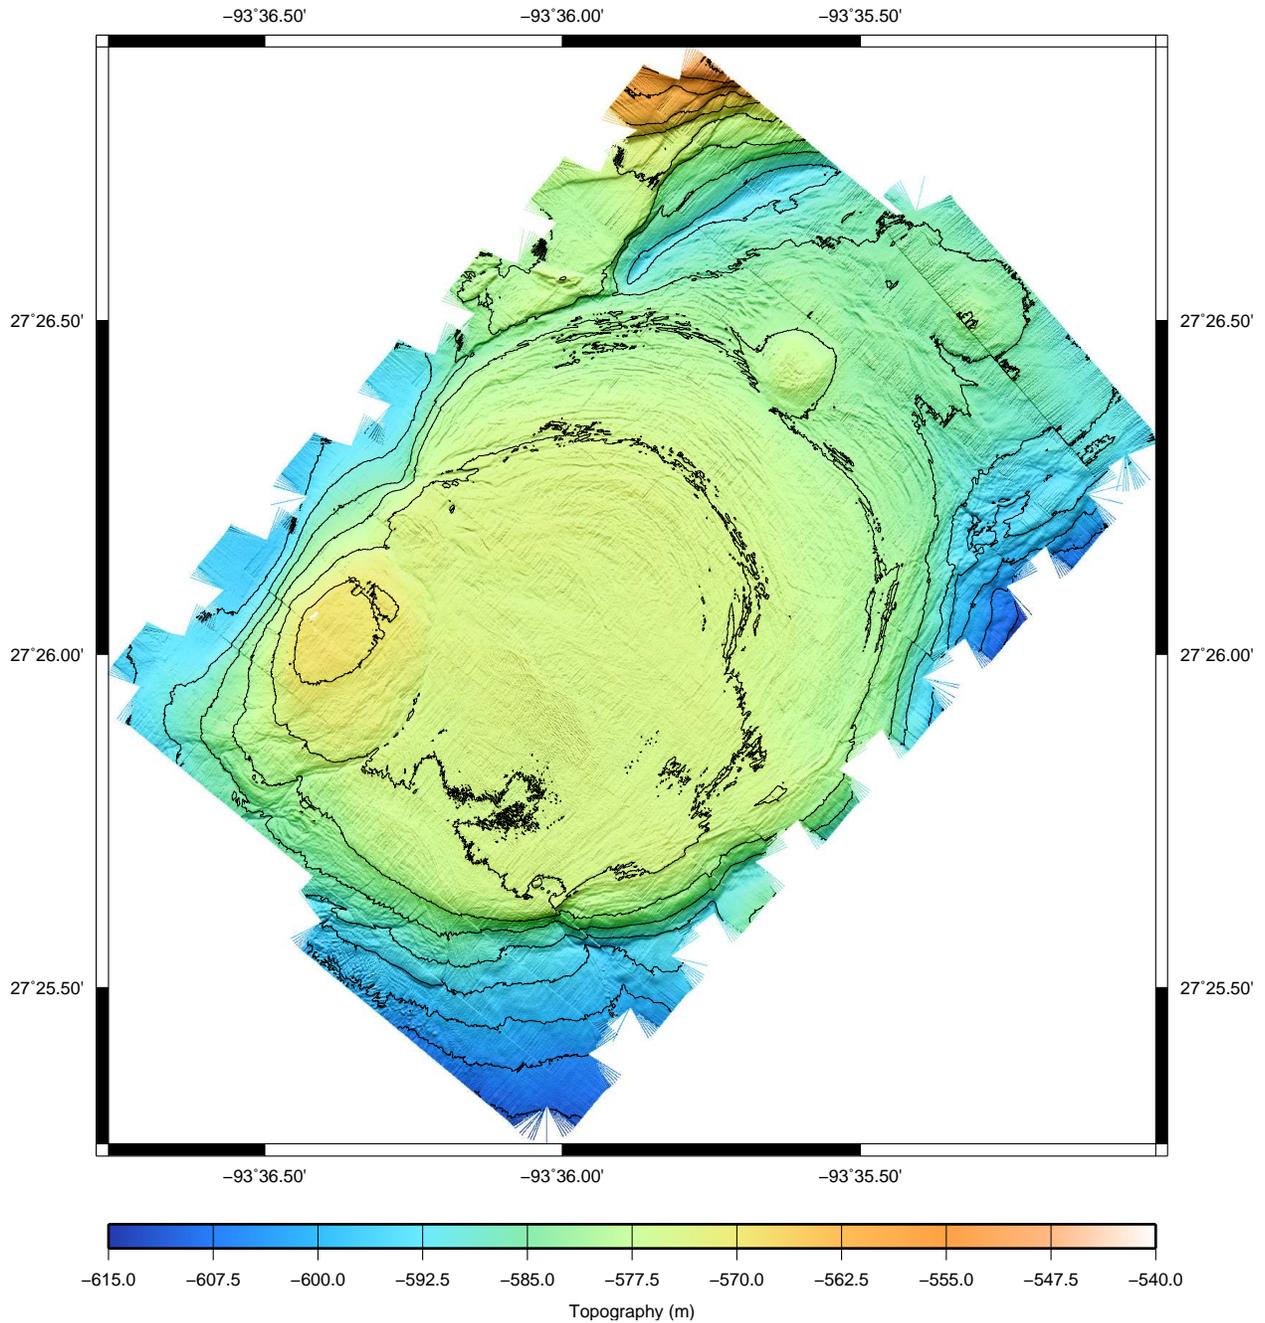
Figure 8: Processed multibeam bathymetry for Sentry021. The map shows minor mismatches between tracklines. Interesting textures can also be seen as can some jitter probably arising from the low-performance tilt sensor which replaced our INS

The resulting multibeam map, gridded at 2 meters, is shown in figure 8. We can see some slight mismatches between tracklines, and each trackline swath looks a bit "shakey" due to the performance of the roll sensor. But overall we were pleased with this result given the makeshift instrumentation we had available. Interesting textural features are visible on the top of the mound.

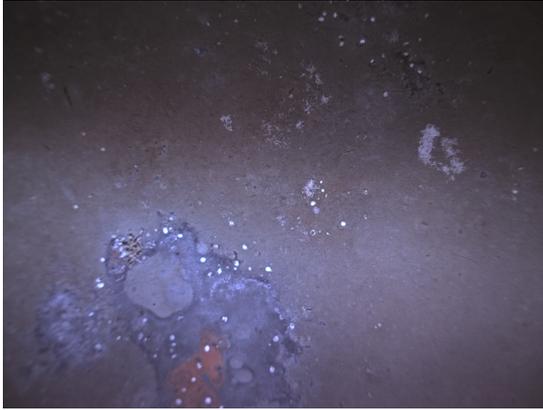
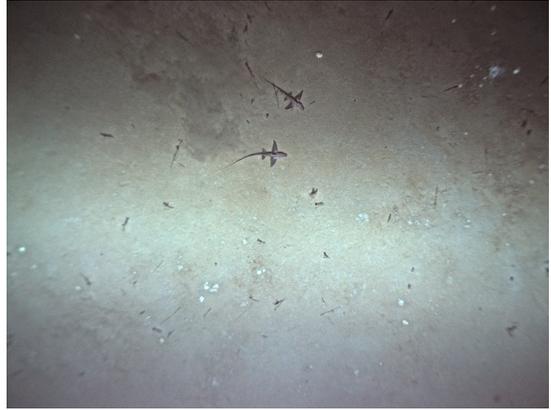
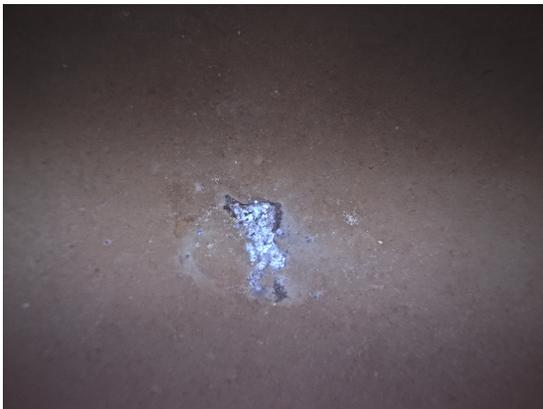
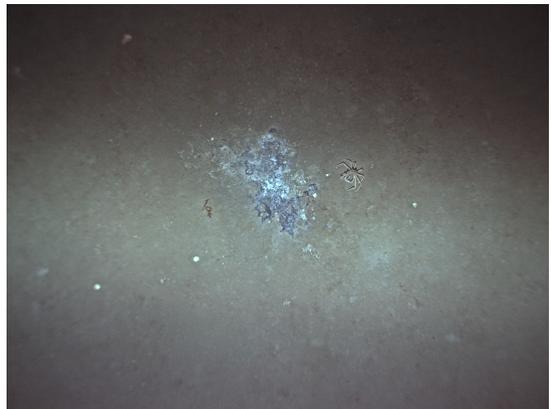
Figure 9: Possible lophelia

Figure 10: Likely chimera

Figure 11: Possible seep

Figure 12: Possible seep with spider crab

The photos proved useful. Lighting was adequate. Focus was good in the center of the images but was soft toward the edges. Figures 9 through 12 show some examples after automated equalization to even out the lighting and color balancing.

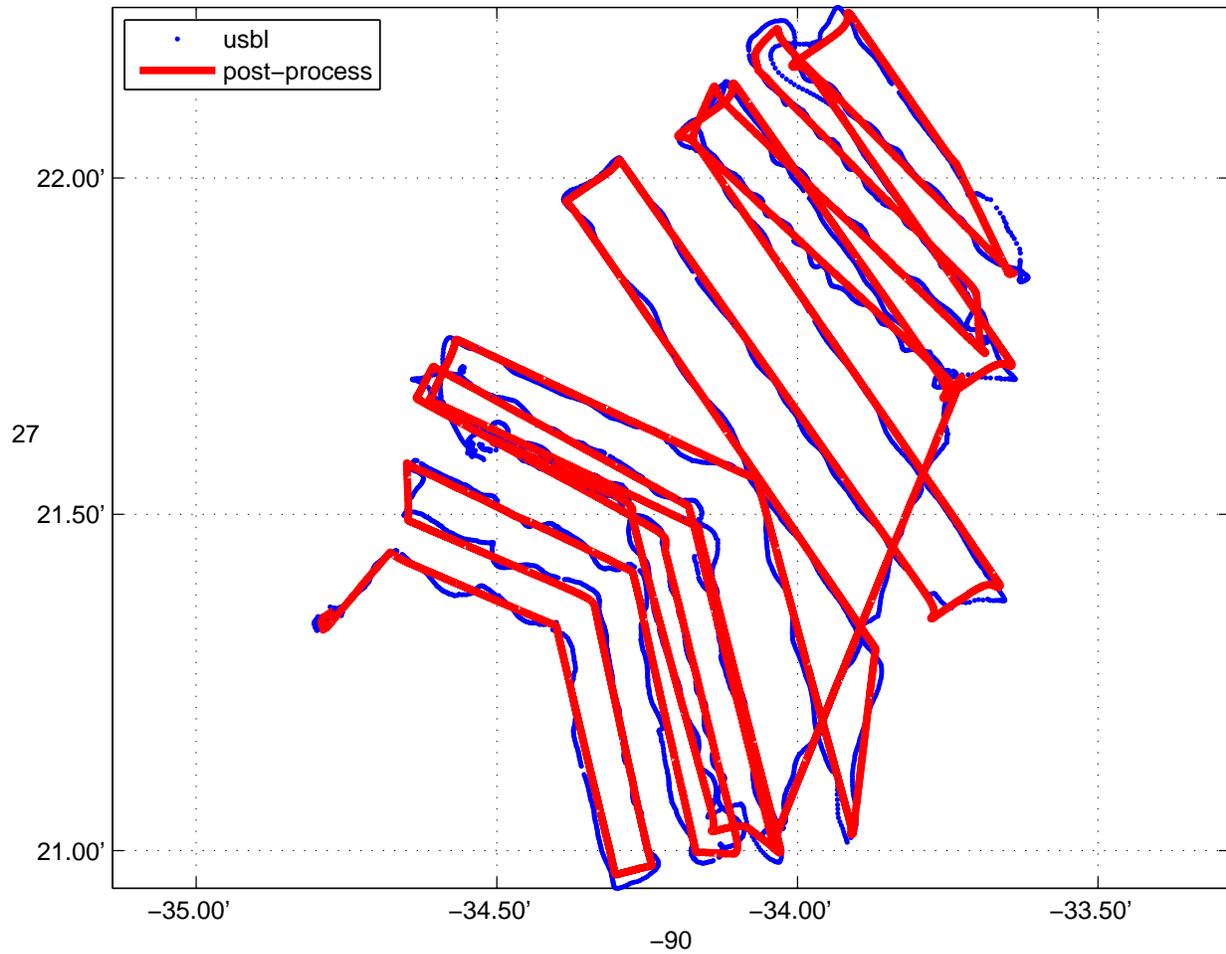
Figure 13: This plot shows the real-time USBL fixes and the post-processed dive track for Sentry023. The USBL performance at this operating depth ($\sim 1100\text{m}$) was degraded substantially over the previous run $\sim 500\text{m}$. This could be a calibration or transducer rigidity issue, clearly the USBL is reporting motions that the vehicle is not making. The post-processed track uses a very sluggish (~ 20 minute) filter on the usbl.
