Deepwater Program: Exploration and Research of Northern Gulf of Mexico Deepwater Natural and Artificial Hard Bottom Habitats with Emphasis on Coral Communities: Reef, Rigs and Wrecks "Lophelia II"

**Cruise 2 Report - Sentry AUV
17 June – 1 July 2009**

TDI-BROOKS INTERNATIONAL, INC.
Technical Report No. – 09-2284

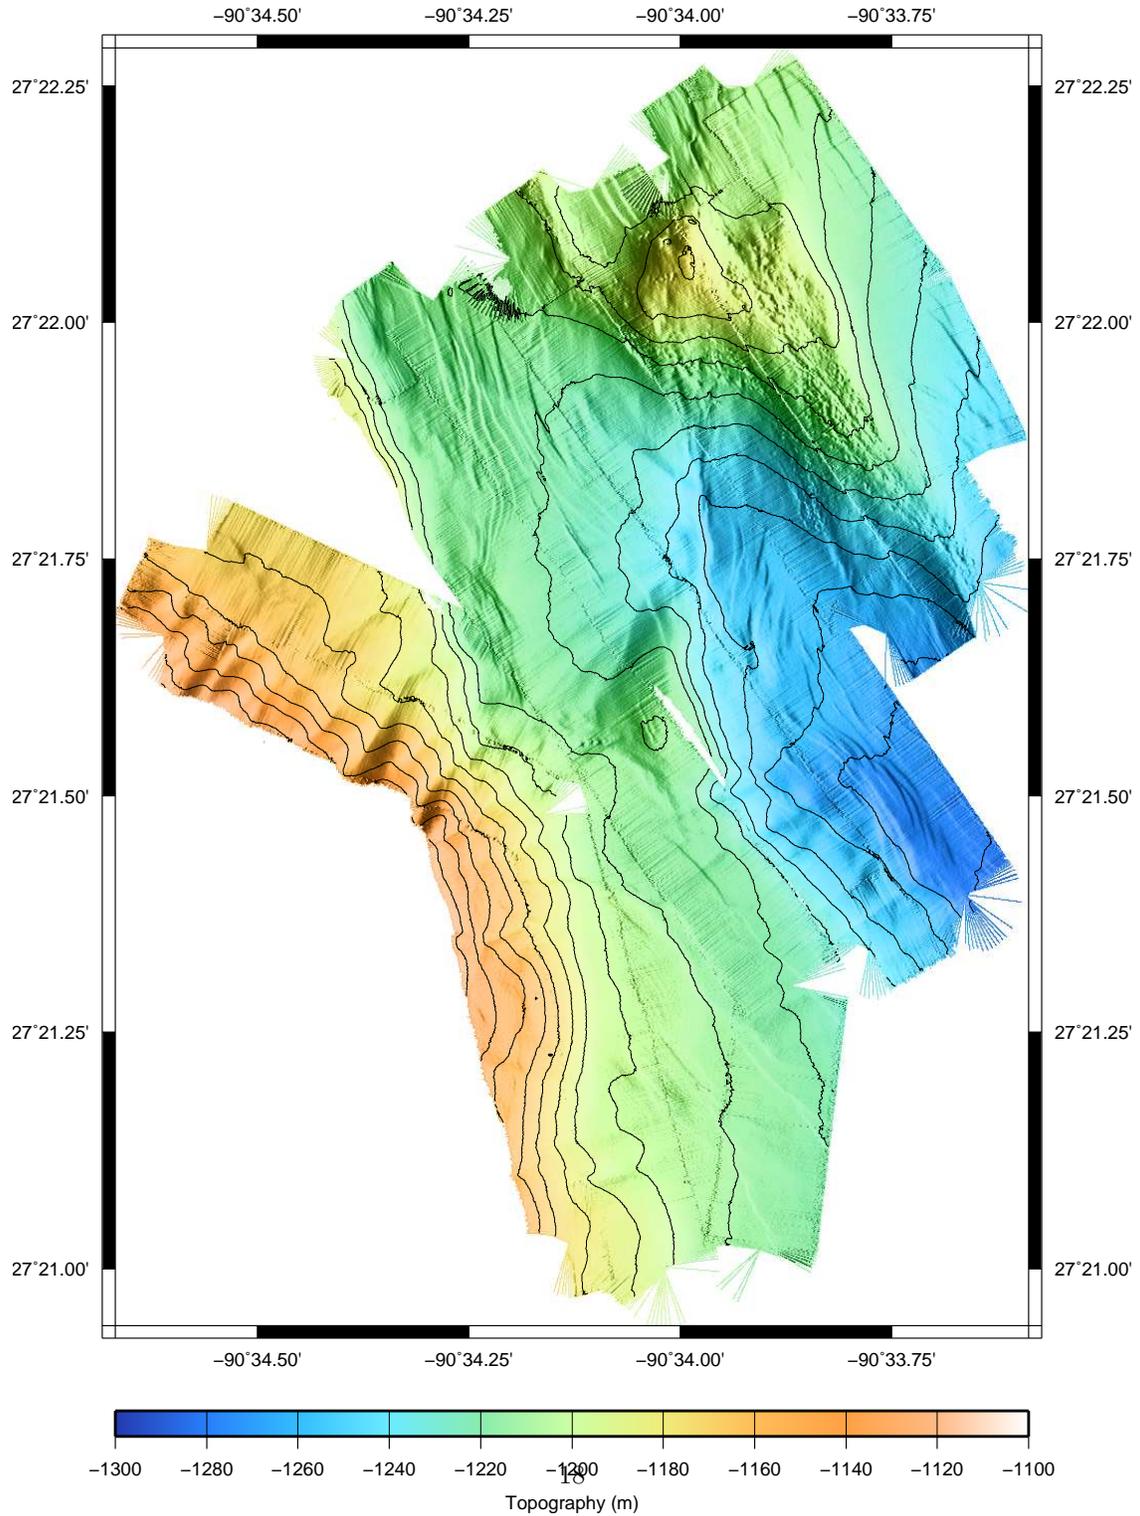
Figure 14: Processed multibeam bathymetry for Sentry023. The map shows minor mismatches between tracklines. Interesting texture can be seen on the steep slope to the north. The map also shows across-track artifacts that occur when the vehicle changes depth while climbing or descending

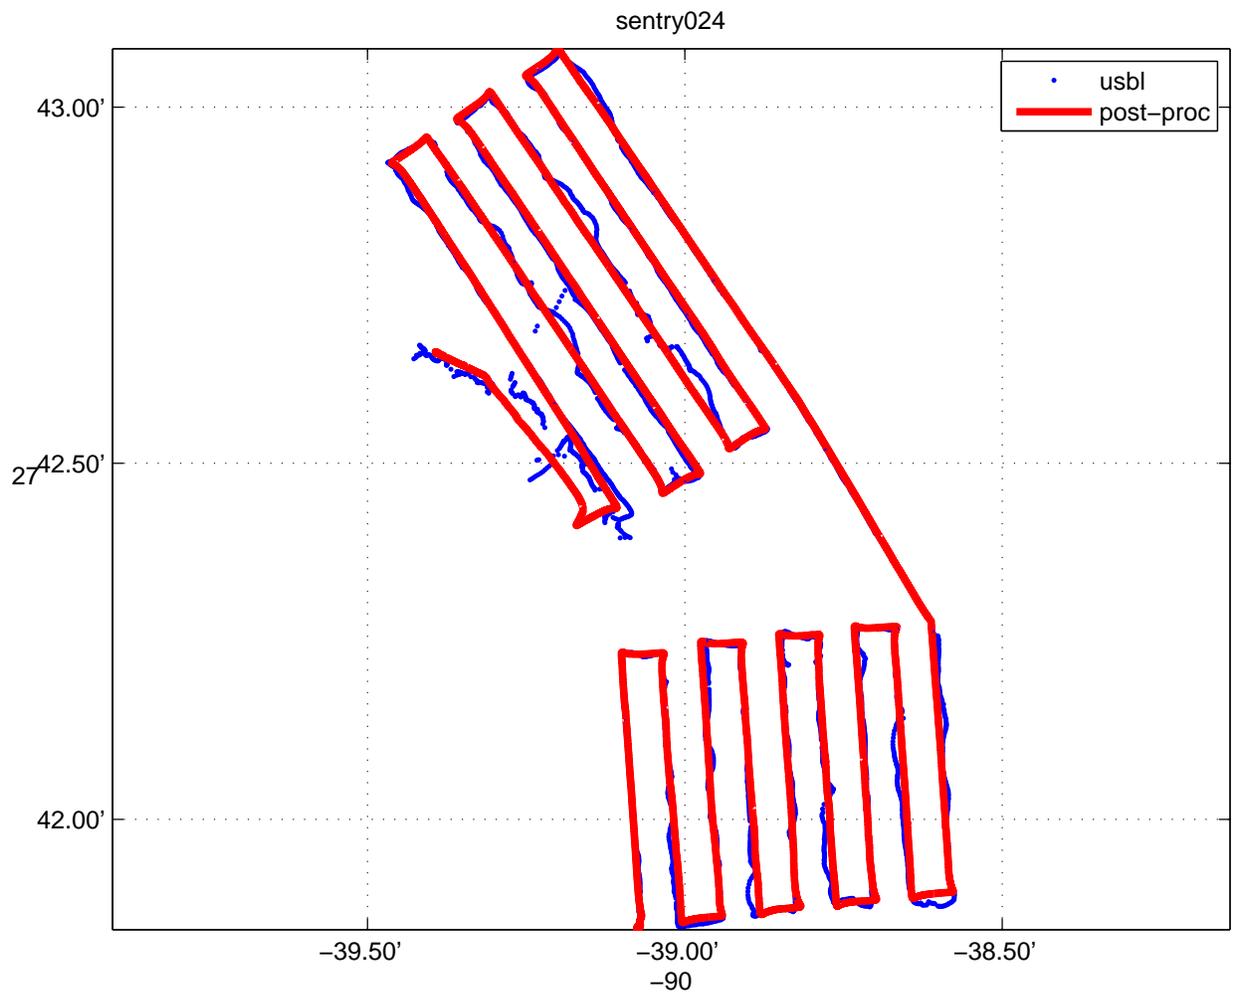
Figure 15: This plot shows the real-time USBL fixes and the post-processed dive track for Sentry024. The USBL performance at this operating depth (800m) was degraded substantially like the previous dive at 1100 m. The post-processed track uses a very sluggish filter on the usbl.

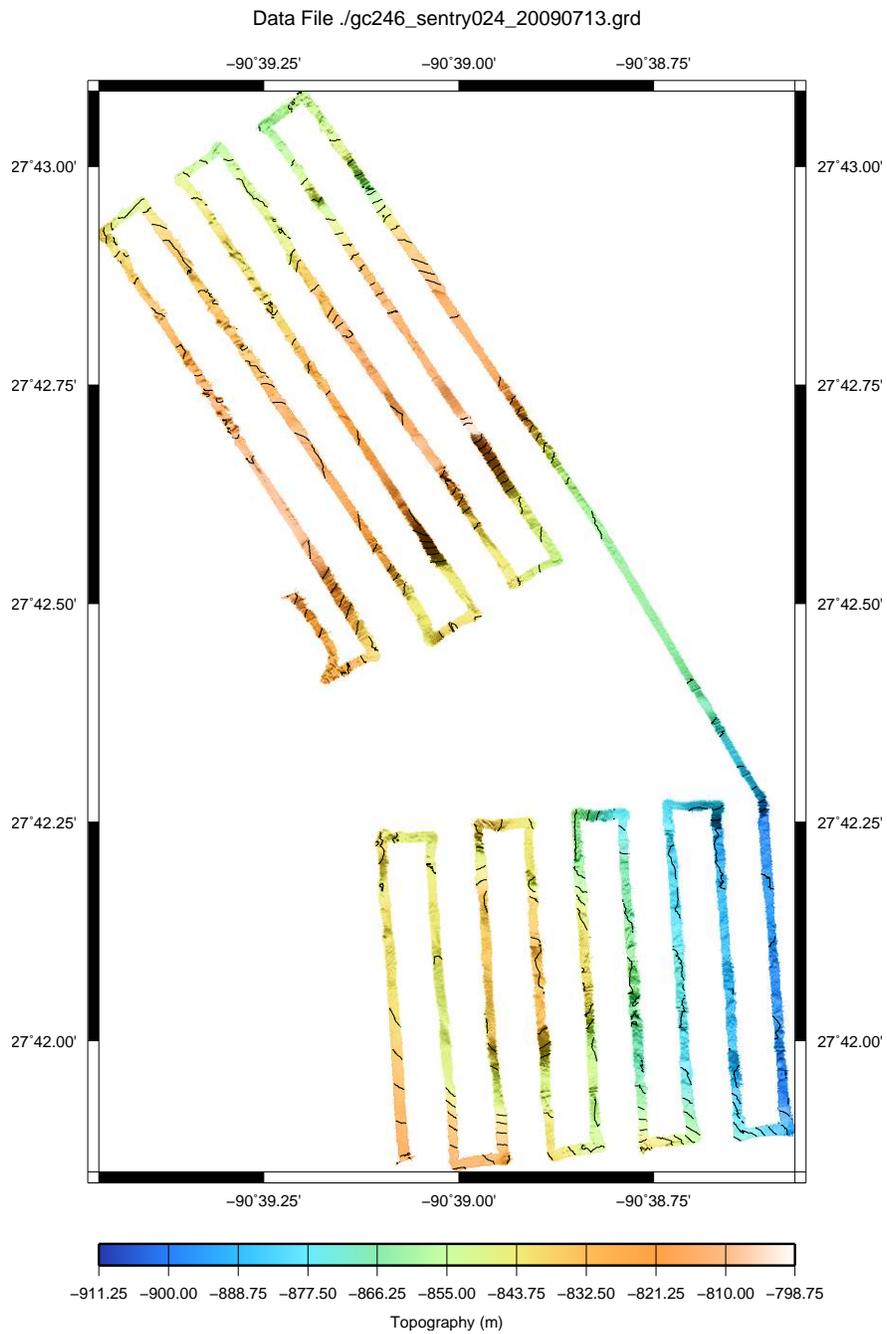
Figure 16: Processed multibeam bathymetry for Sentry024. The swath is very narrow, as the only multibeam data was taken at 5 m height. Close up views of the tracks show texture in a few spots.

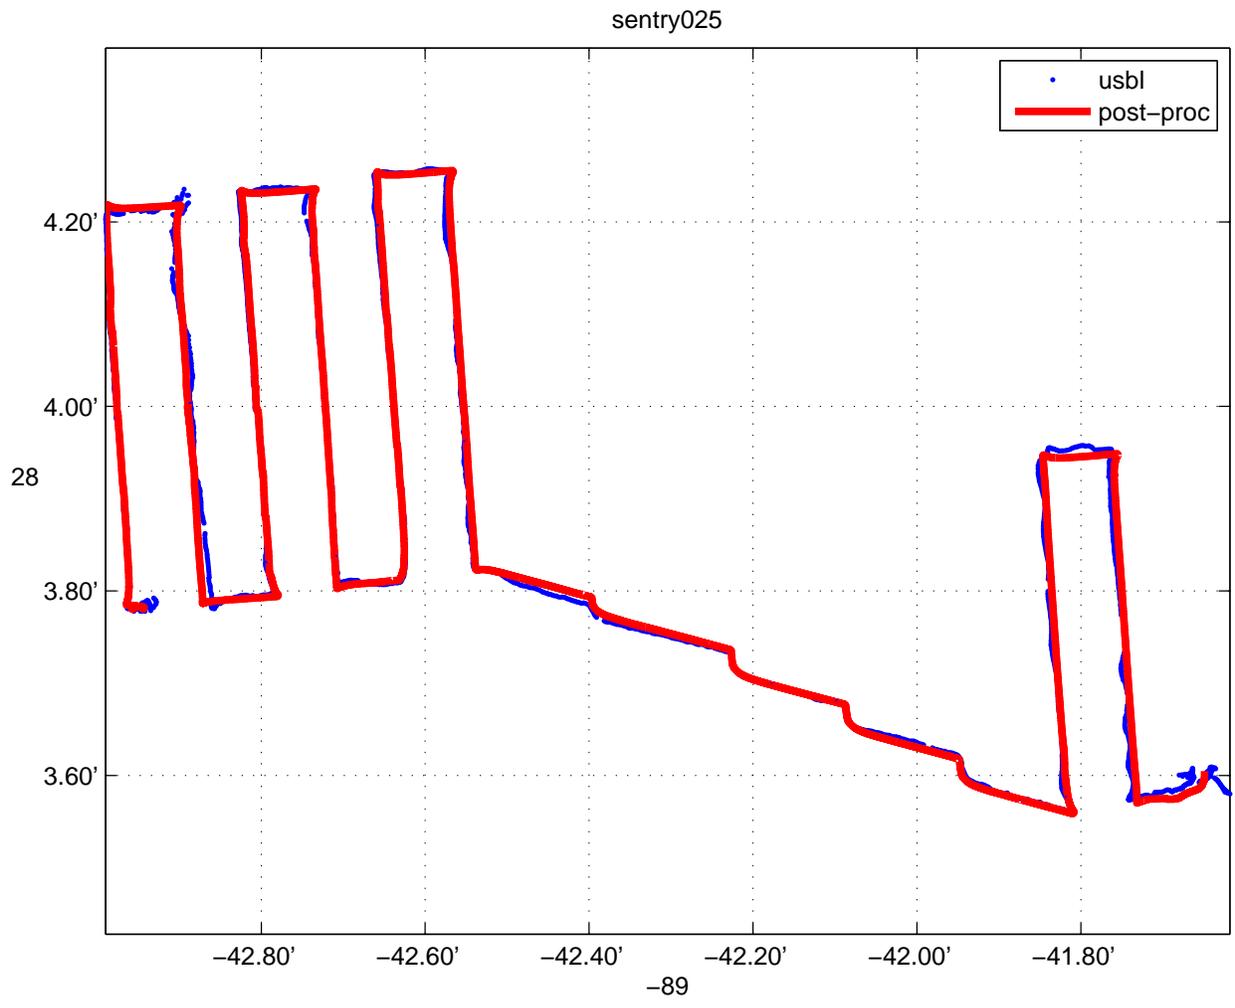
Figure 17: This plot shows the real-time USBL fixes and the post-processed dive track for Sentry025. The USBL performance at this operating depth (600m) was nearly comparable to the excellent performance obtained on the earlier shallow dives.

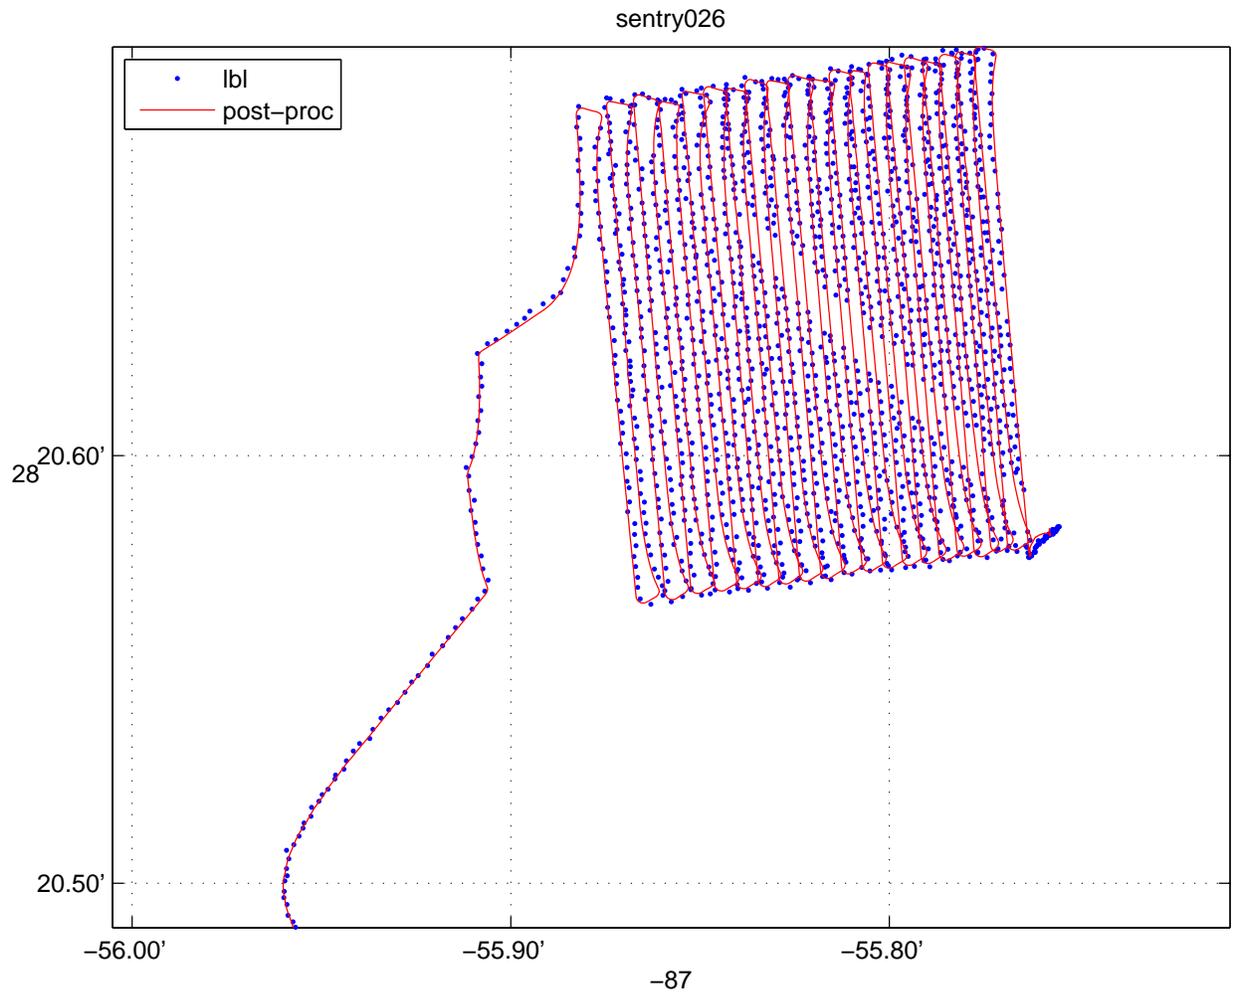
Figure 18: Post-processed dive track and LBL fixes for Sentry026. The lbl fixes were highly repeatable. The orientation of the grid reflects an error (declination?) in our calibrated magnetic compass. Fortunately this error applied nearly equally in both directions. The gap in the LBL fixes occur along a strip where the travel times would be exactly the same, which confuses the receiver.

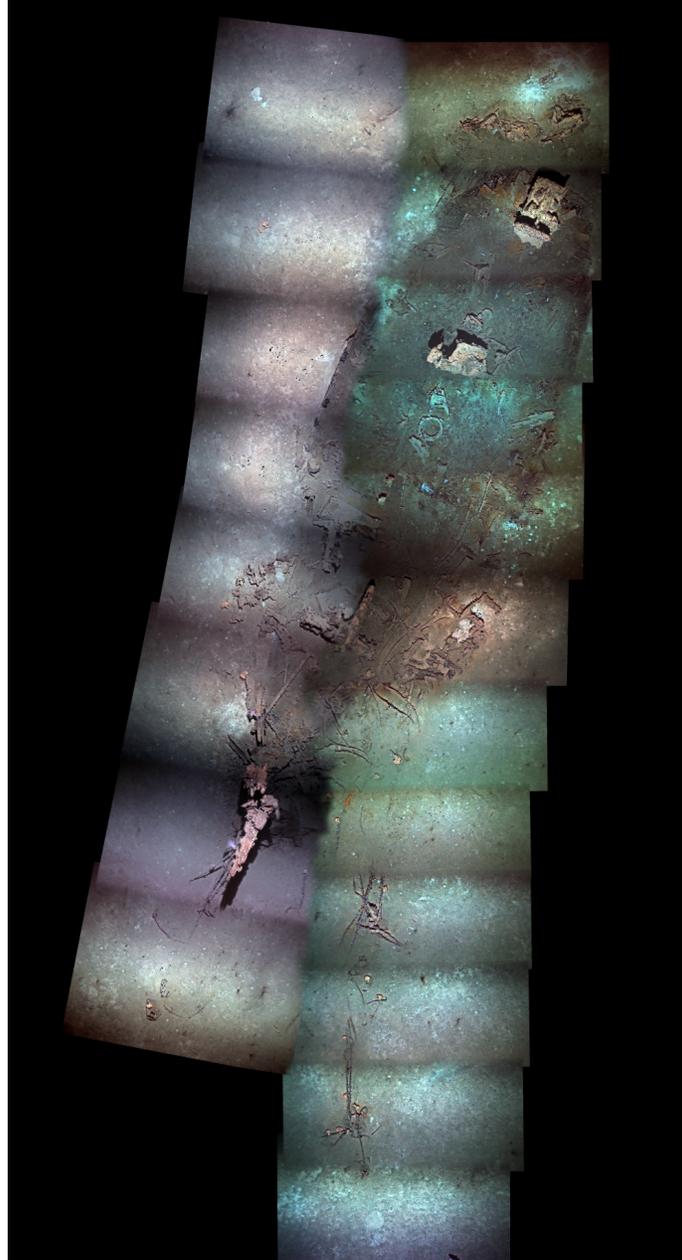
Figure 19: This image shows a photomosaic of the shipwreck assembled by Dr. Ian MacDonald and other members of the science party. The combination of 5 meter line spacing, excellent trackline following, and the field of view of the camera provided overlapping coverage

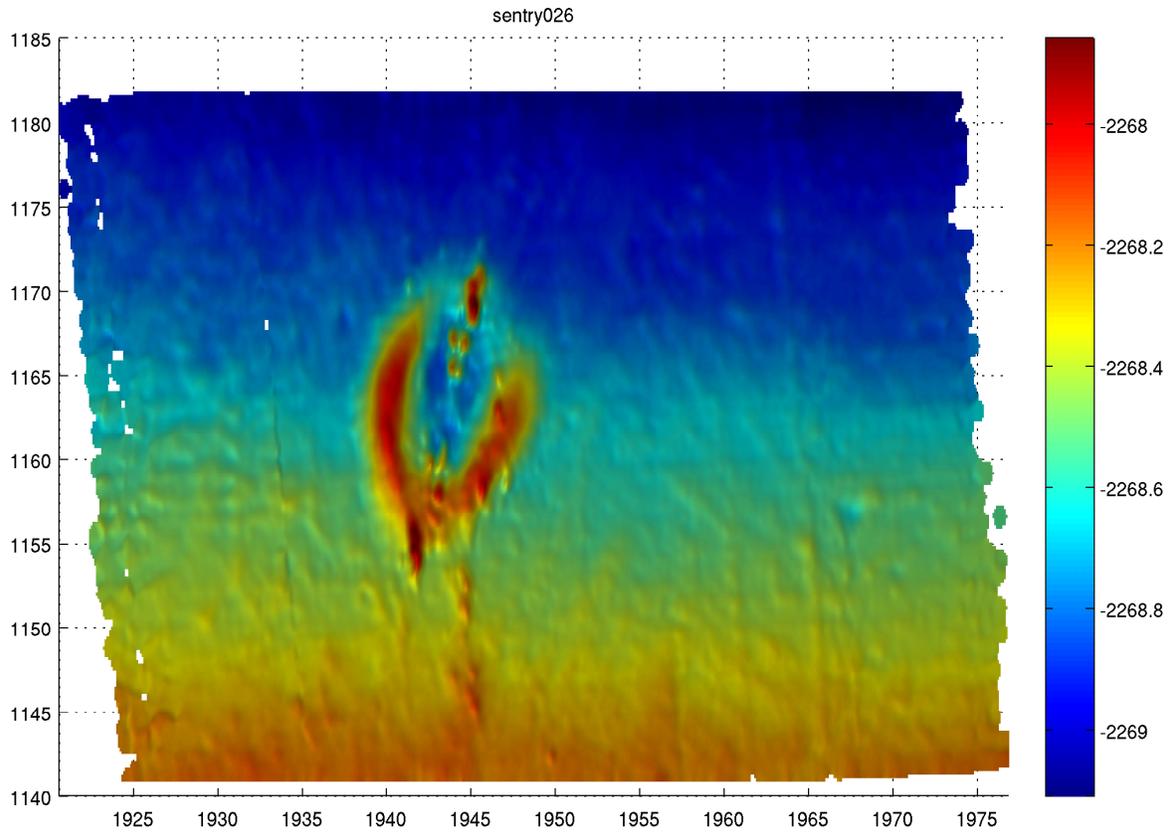
Figure 20: Gridded bathymetry for Sentry026. The data was gridded at 0.1m in the EW direction and 0.3m in the NS direction to reflect the sounding density in those respective directions. We used MB-system to produce the point cloud, but gridded the data in Matlab, which provided more flexibility. The plot above uses simple mercator (Alvin xy) coordinates with an origin at 28 20.0000 -87 -57.0000

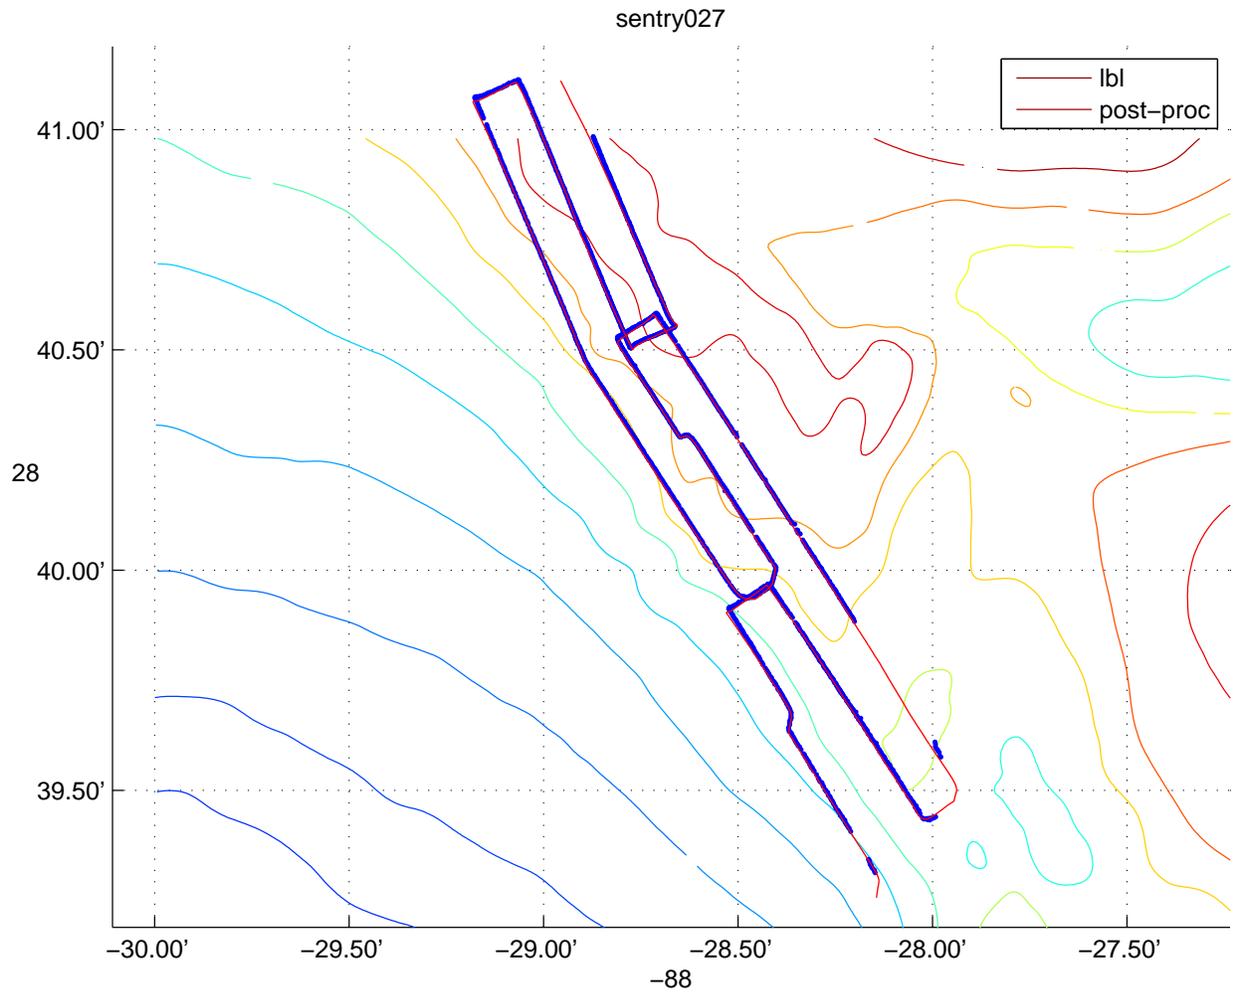
Figure 21: This plot shows the LBL fixes and the post-processed dive track for Sentry027.

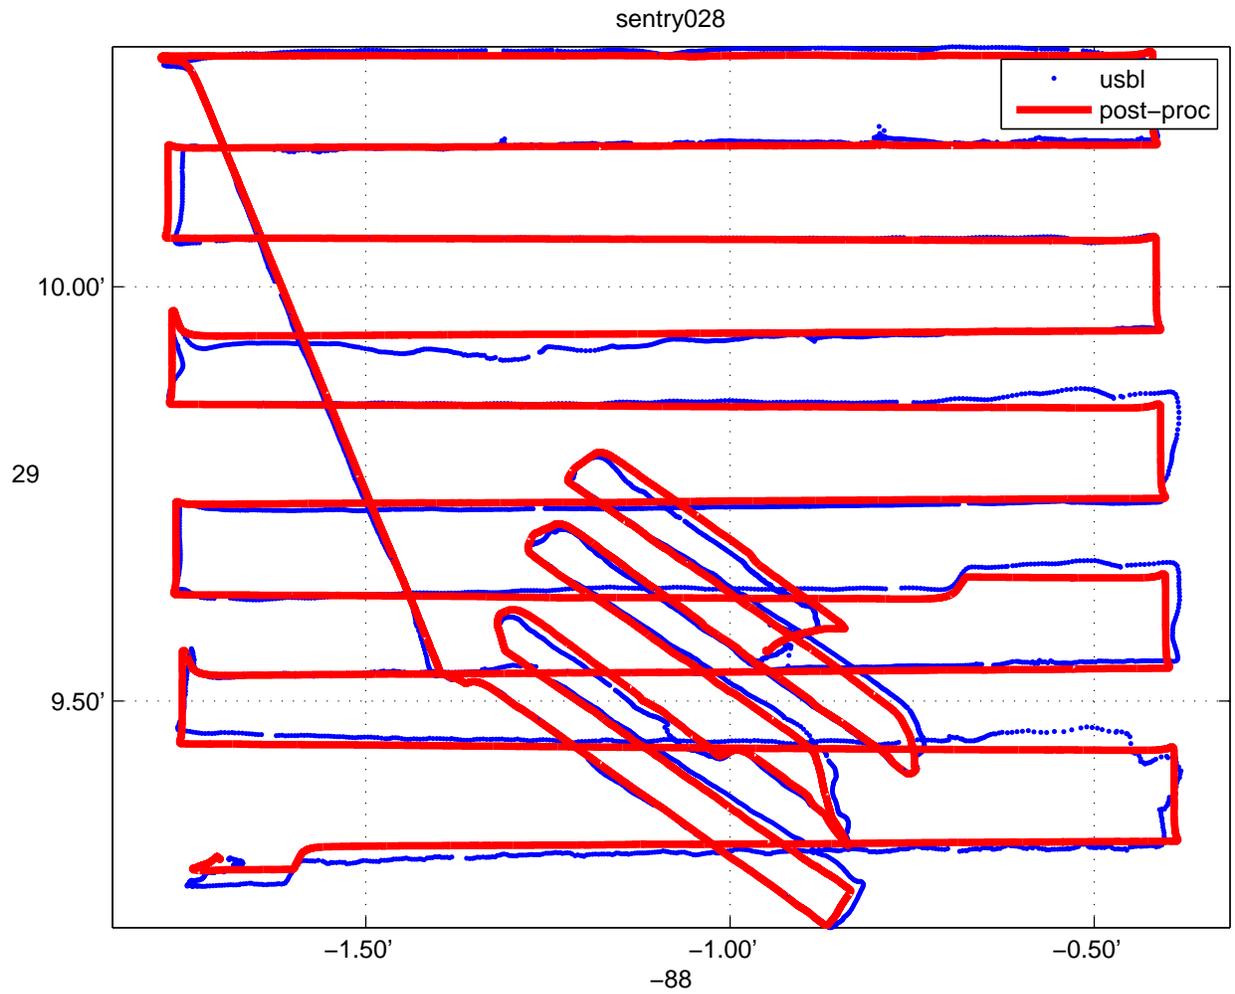
Figure 22: This plot shows the USBL fixes and the post-processed dive track for Sentry028. The USBL performance at this operating depth (600m) was nearly comparable to the excellent performance obtained on the earlier shallow dives.

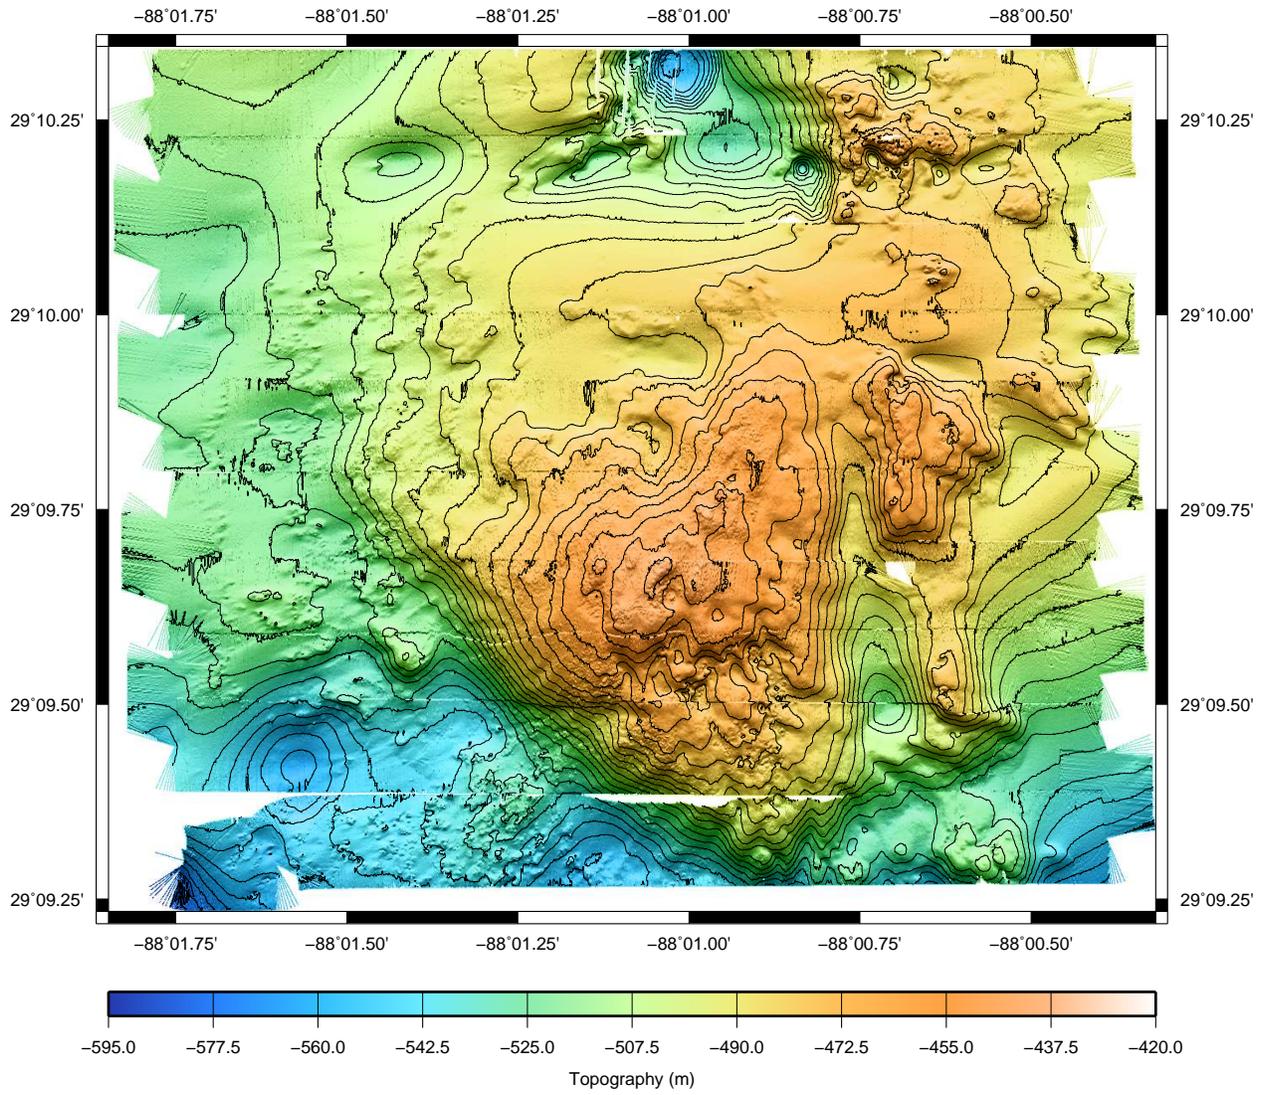
Figure 23: Gridded bathymetry for Sentry028

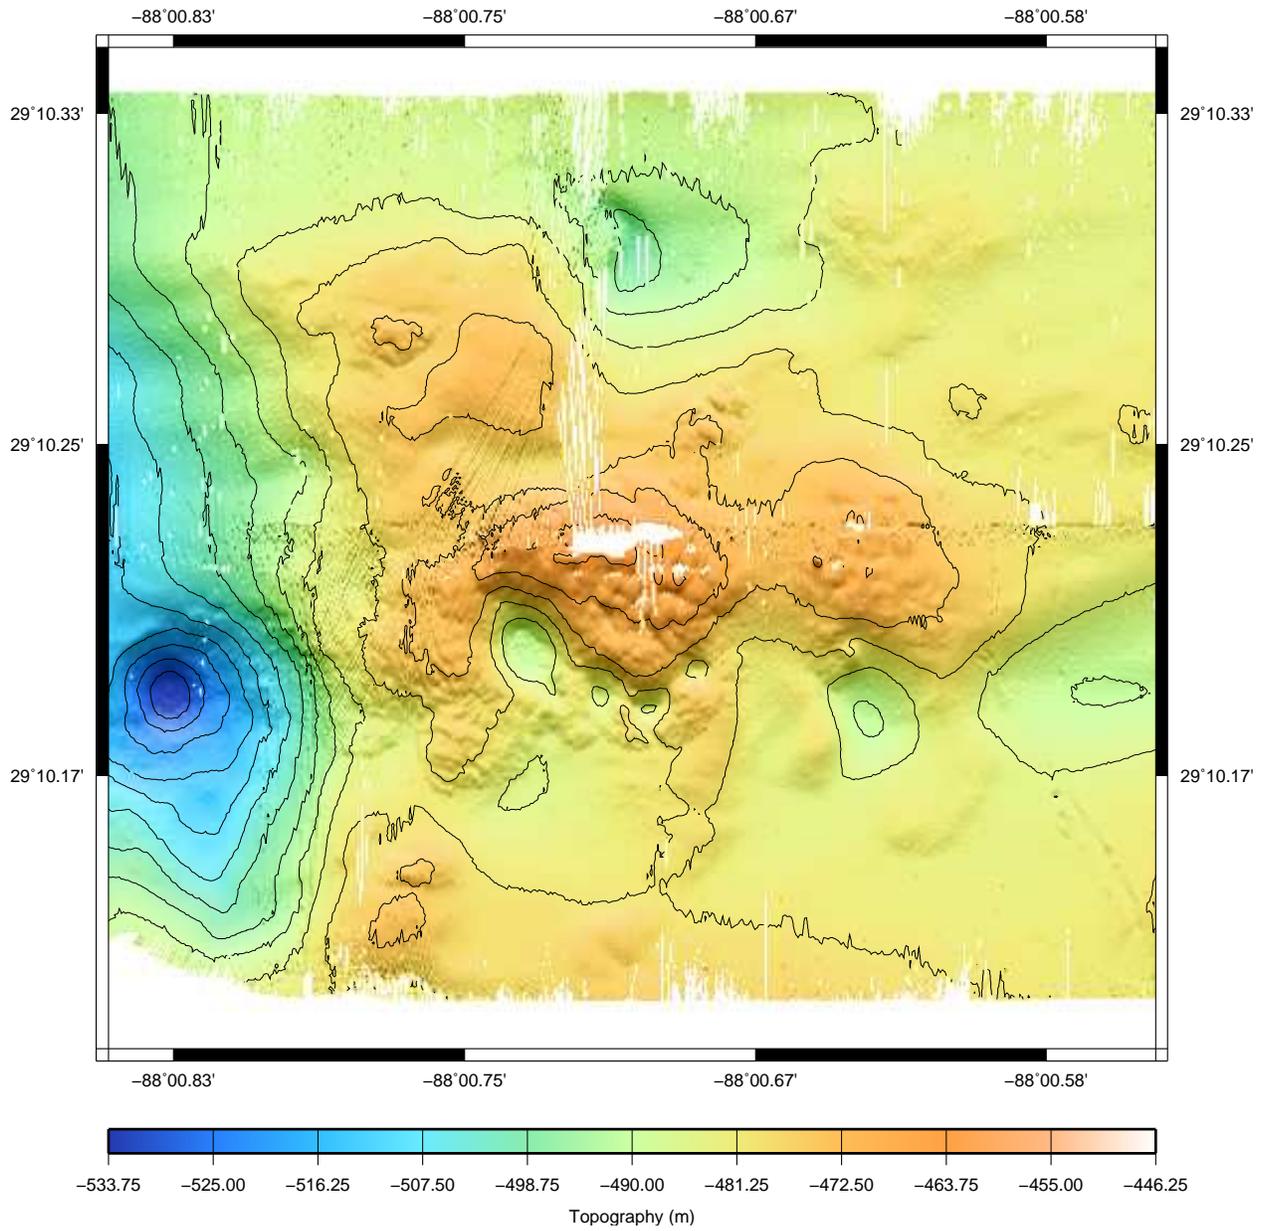
Figure 24: Gridded bathymetry for Sentry028, feature to the north

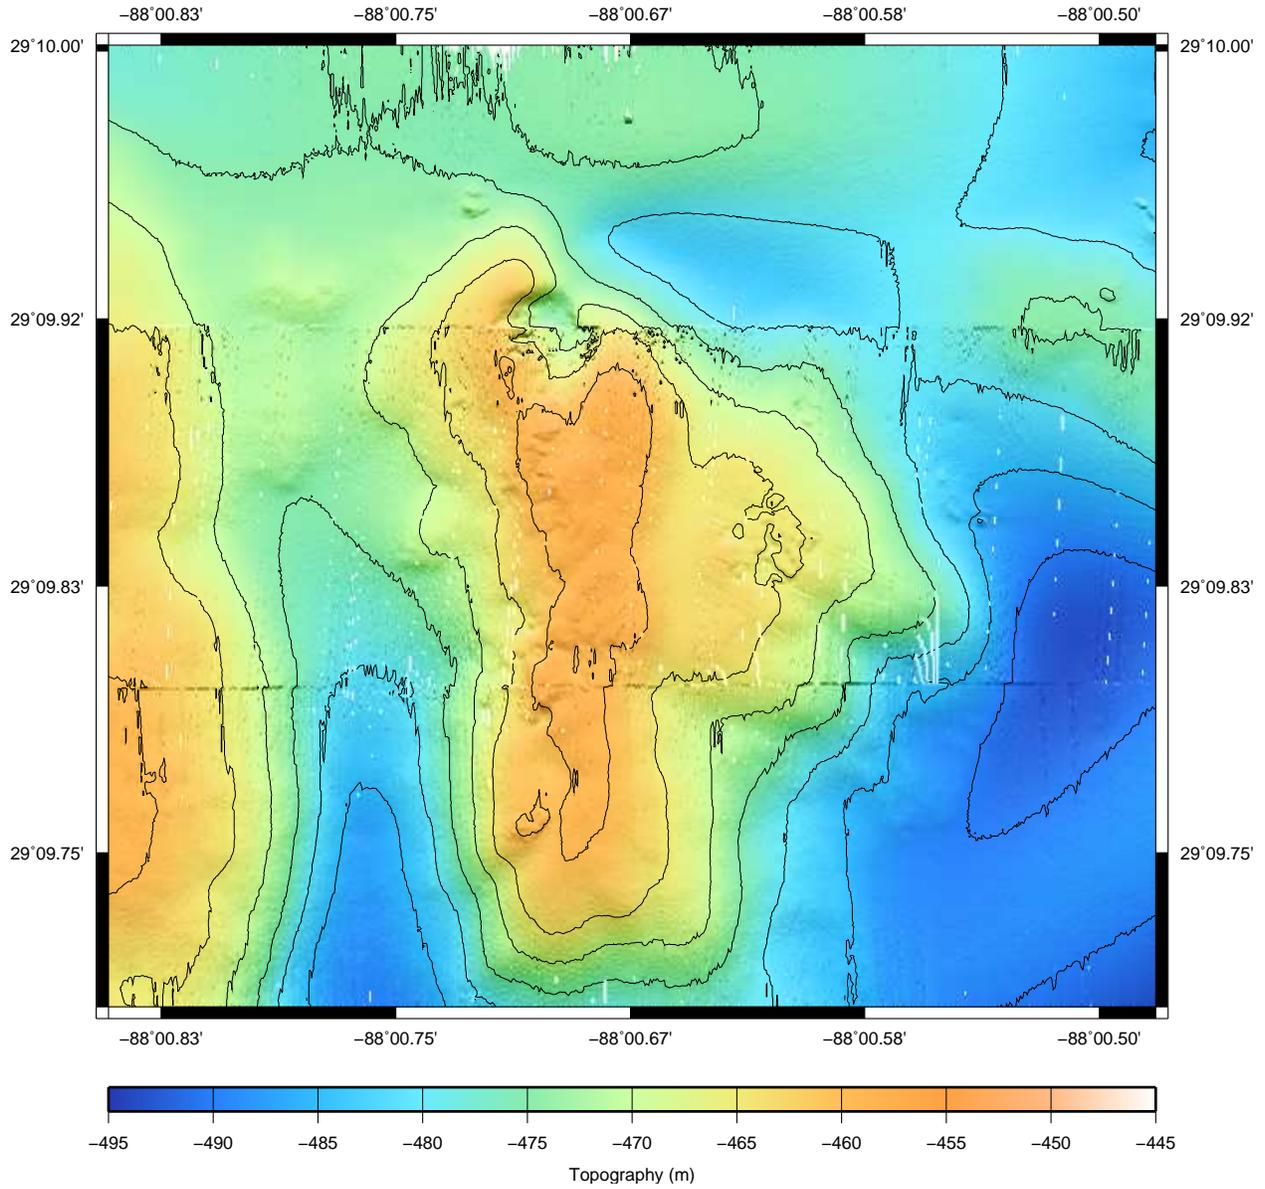
Figure 25: Gridded bathymetry for Sentry028, feature to the east

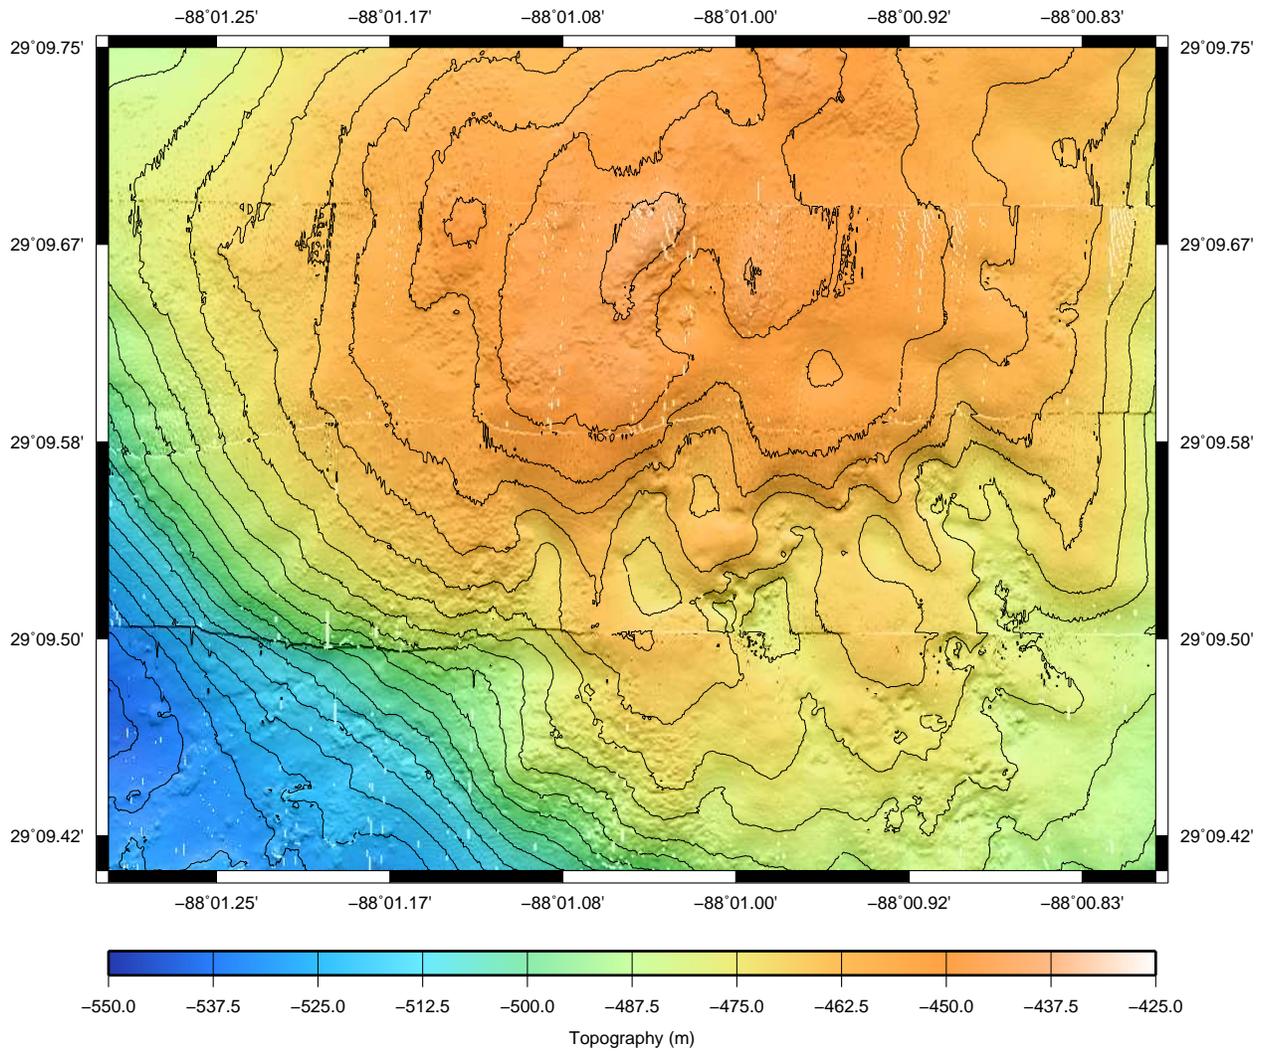
Figure 26: Gridded bathymetry for Sentry028, feature to the south
